USARTL-TR-78-22

# CH-47 CRASH TEST (T-40) STRUCTURAL, CARGO RESTRAINT, AND AIRCREW INFLATABLE RESTRAINT EXPERIMENTS

L. Burrows, R. Lane, J. McElhenney

April 1978

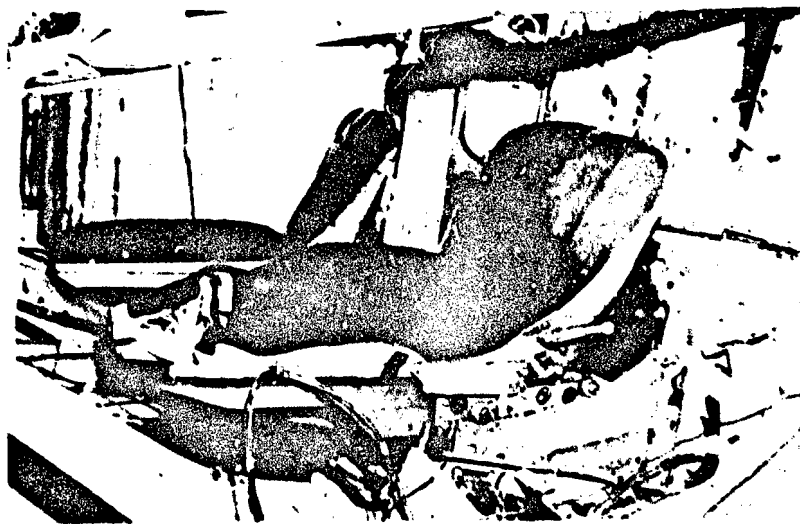
Standard CH-47A seats were installed in the test specimen. As shown in Figure 17, both seat pans broke as a result of the crash impact. While the failure of the copilot inertia reel allowed the dummy to pitch forward, the pilot inertia reel engaged, causing the restraint to tear the back of the seat. This is also shown in Figure 17.

Figure 17. Seat pan failure.

3. Seat pan failures at both the pilot and the copilot stations are indicative of the severe tailward decelerations experienced by occupants in a 95th percentile potentially survivable impact. Had this been a manned helicopter, it is most probable that the pilot and copilot would have sustained incapacitating injuries.

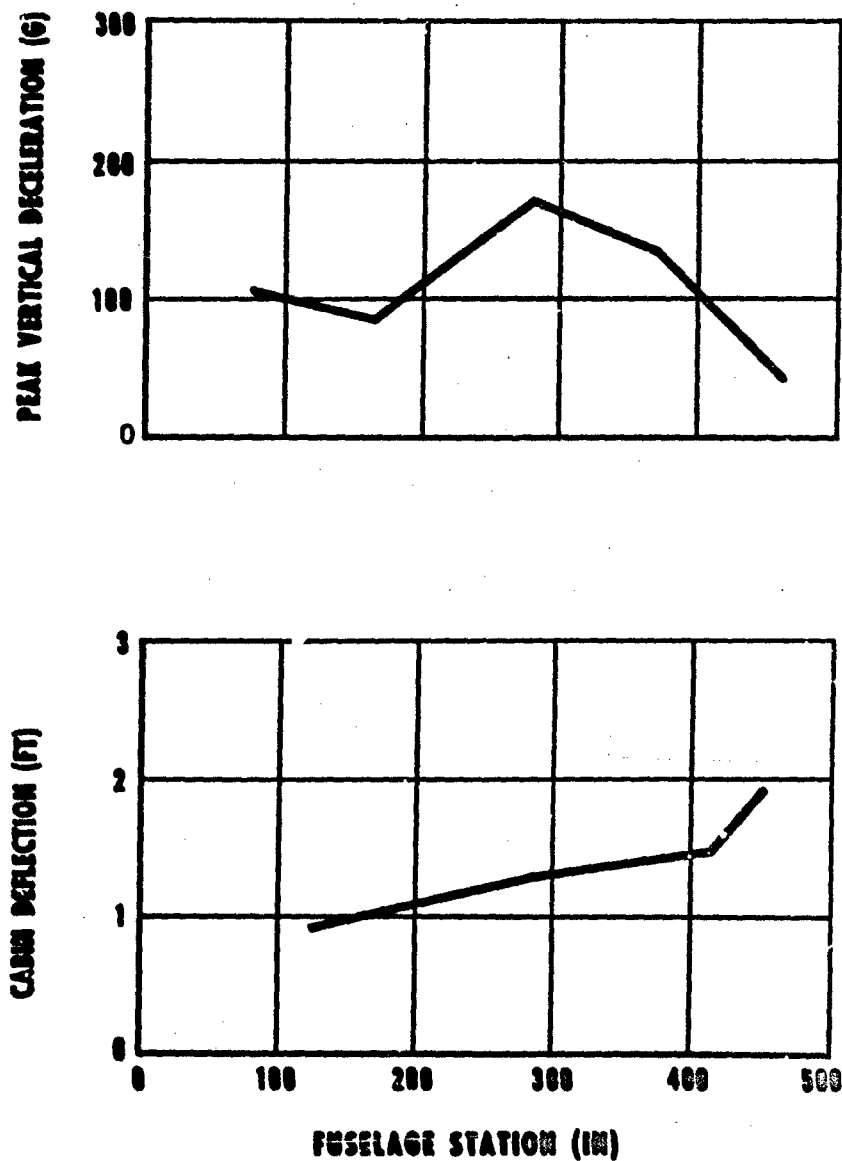
Figure 18 shows the variation of the 100-Hz filtered peak decelerations (measured along the cabin floor centerline) and the cabin height reduction with the aircraft station.

Figure 18. Variation in peak decelerations and cabin height reduction with aircraft station.

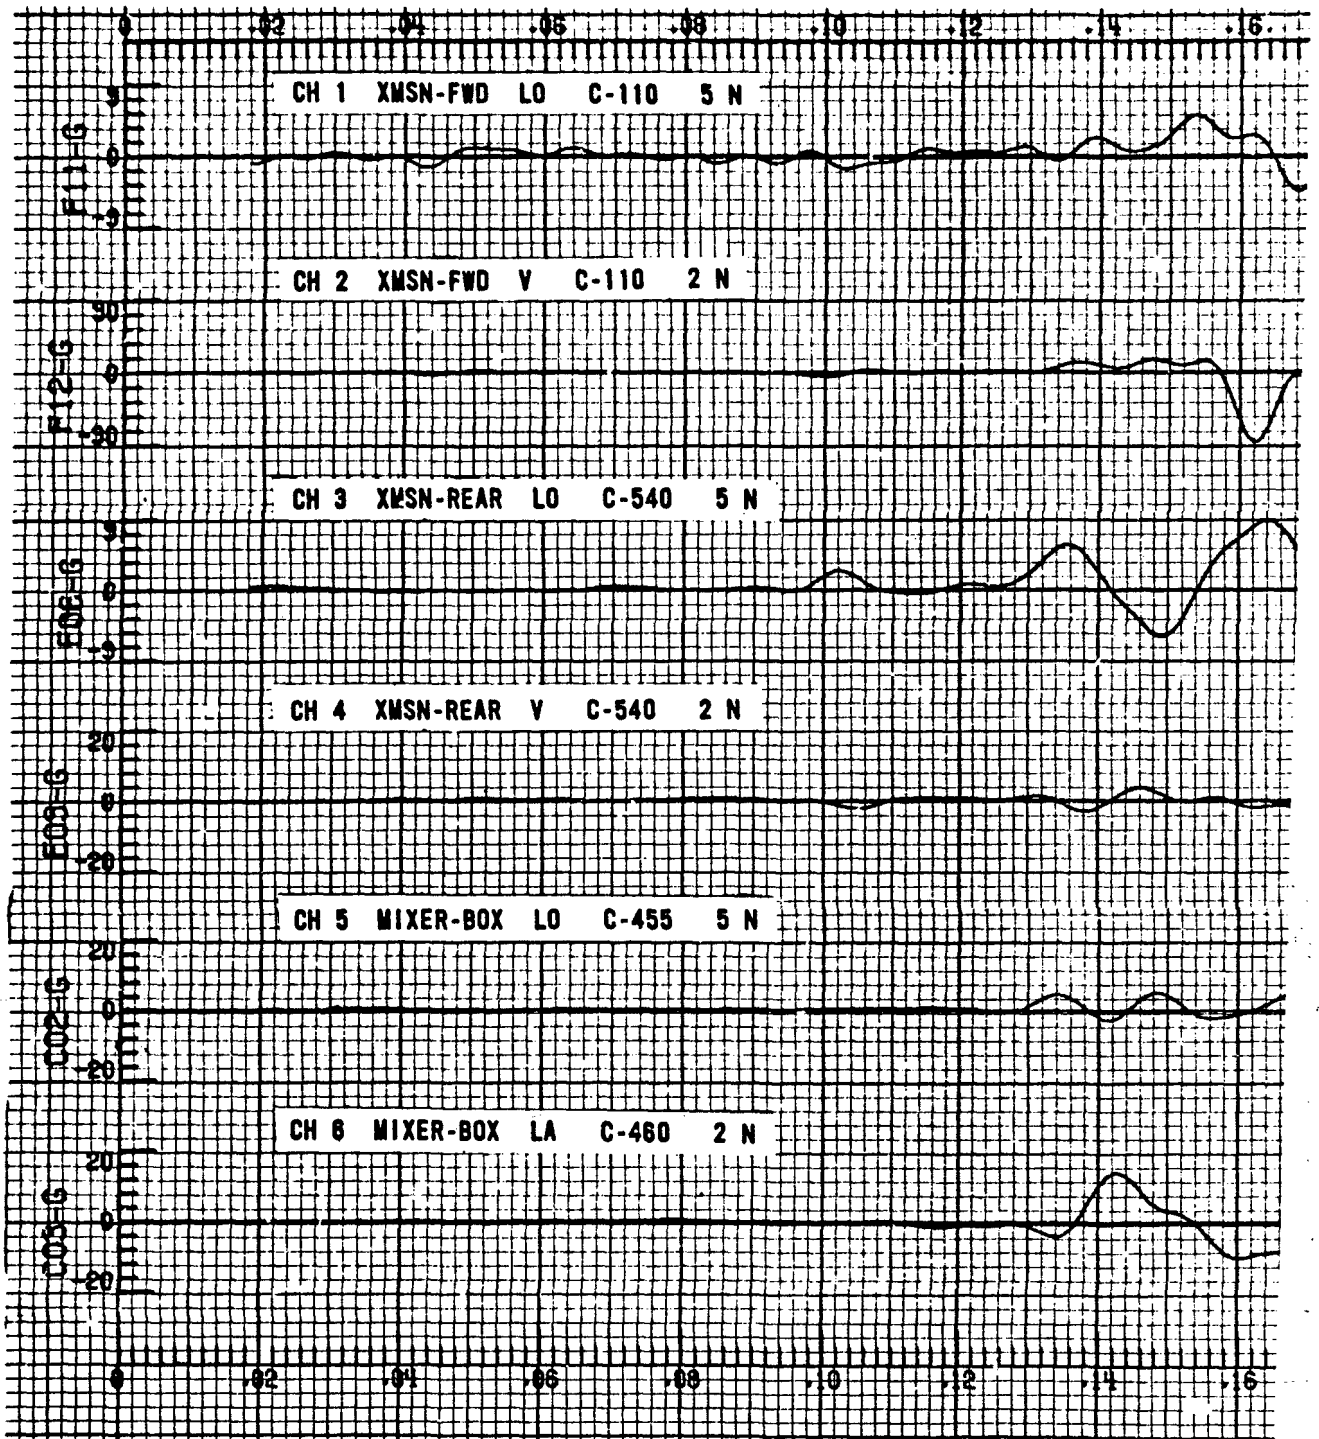
The deceleration time history during impact for the engines and transmissions is presented in Figures 19 and 20 respectively. Comparison of these data with Figure 21, which gives the cabin floor and landing gear attachment deceleration time history, illustrates the energy-absorption capability of the deforming structure. For instance, deceleration readings in the vertical direction range from 210.5 G at the rear right landing gear at station 482, to 59.8 G at the floor centerline at station 460, to 9.2 G at the rear transmission at station 540.

Figure 19. Gearbox decelerations.

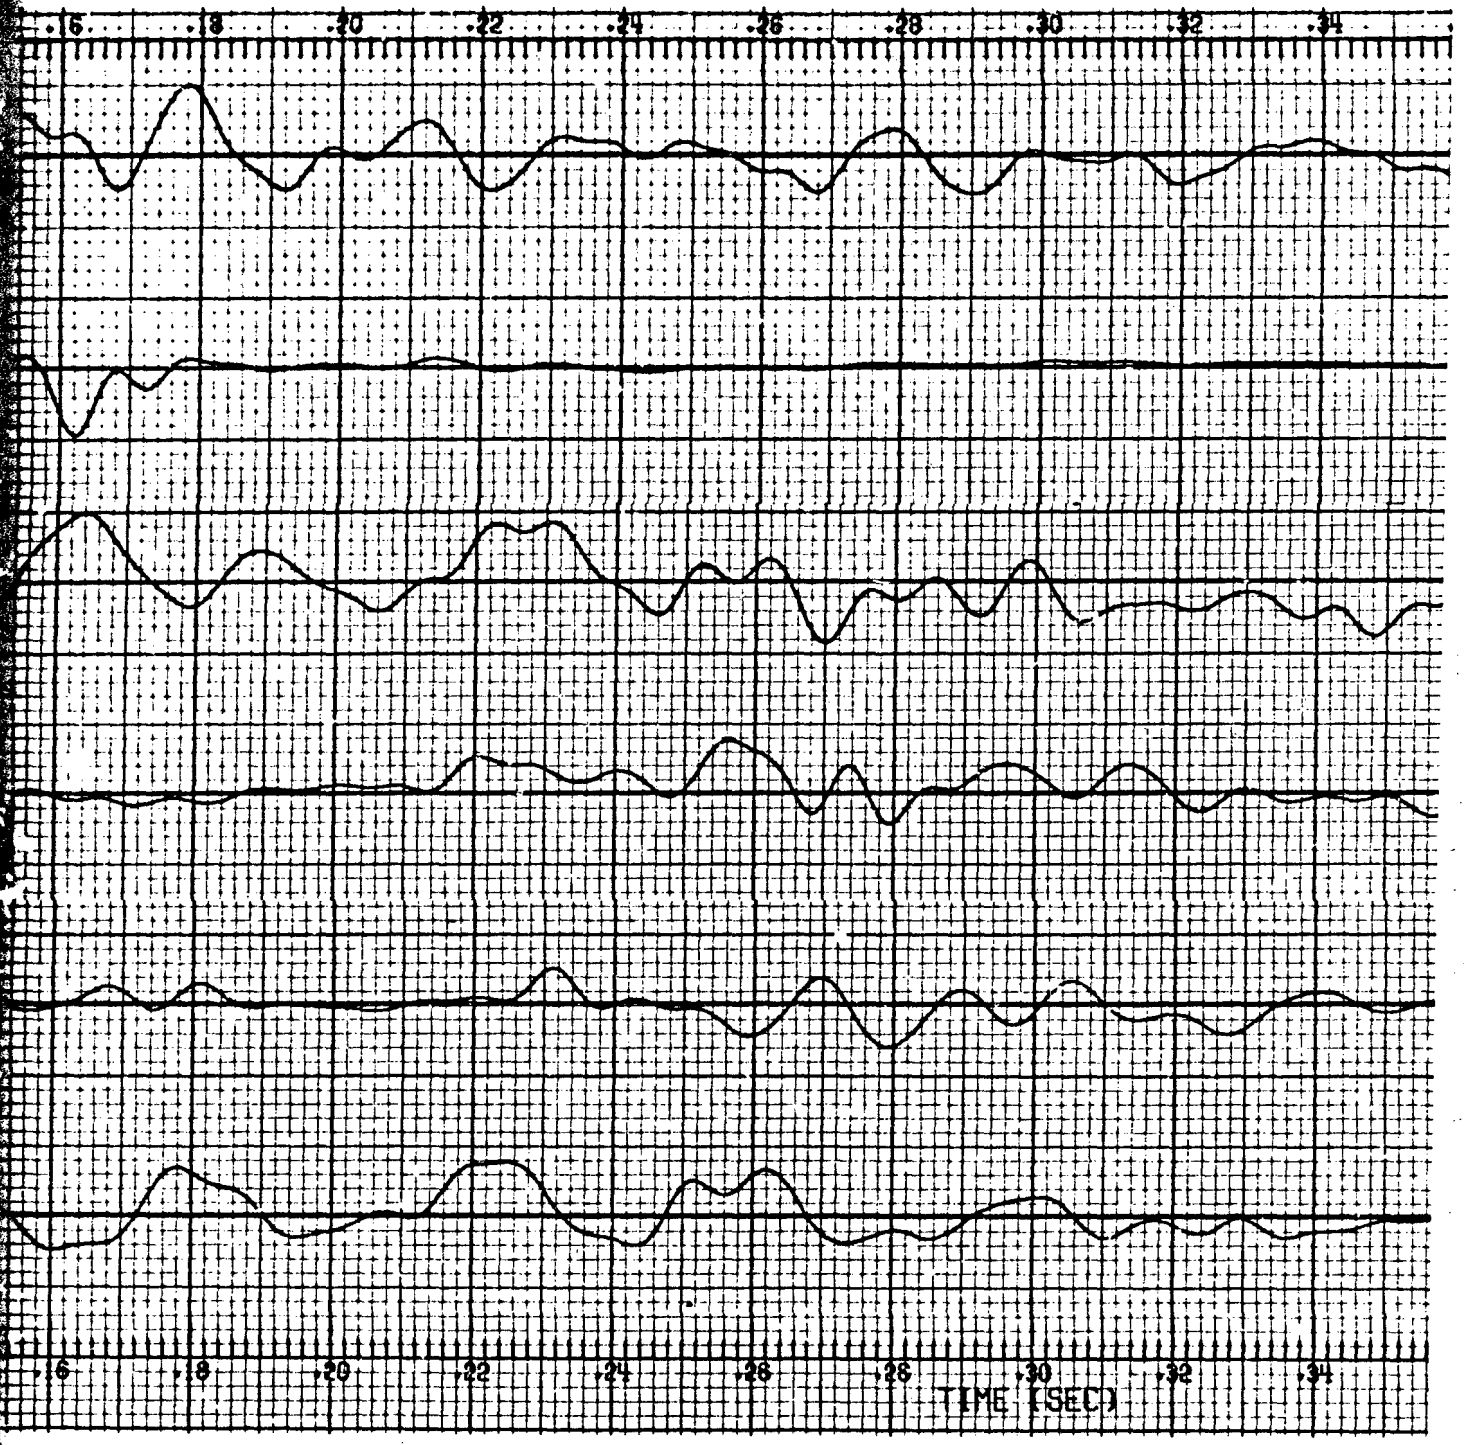
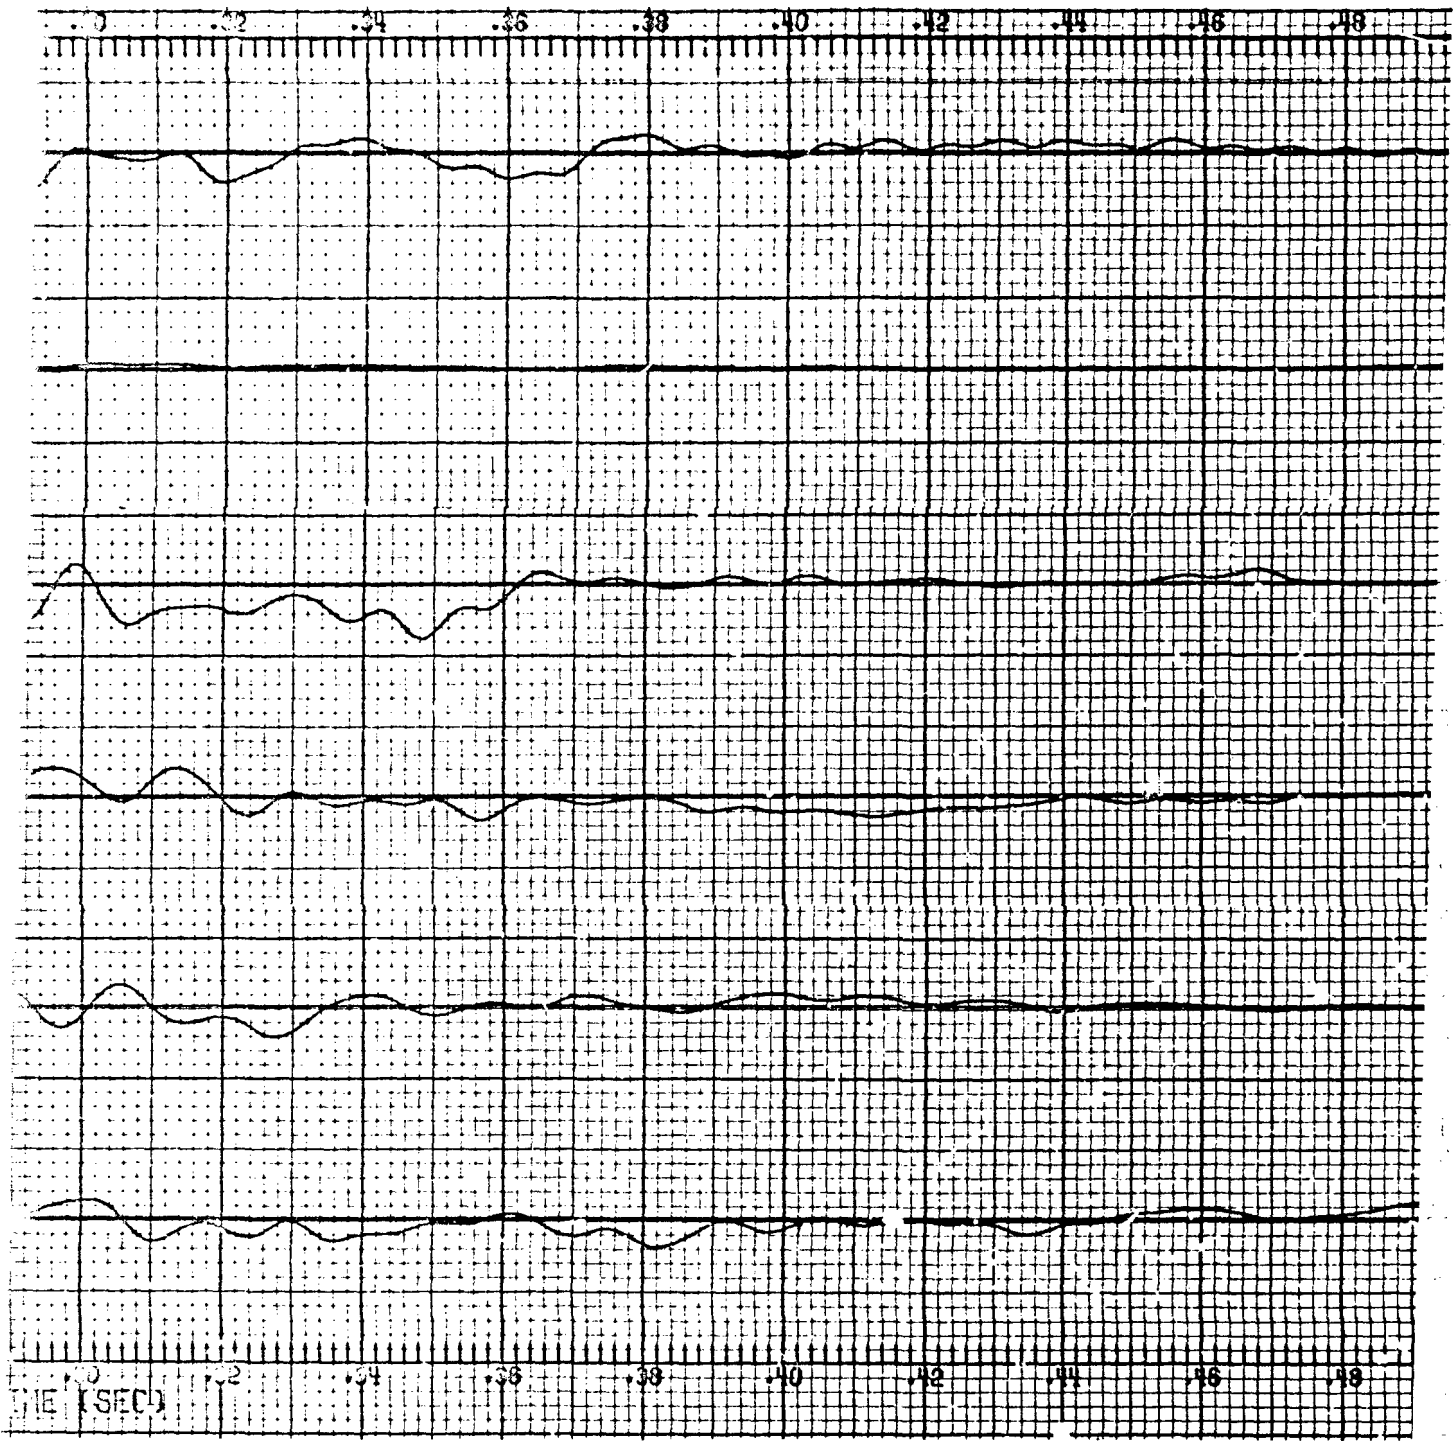
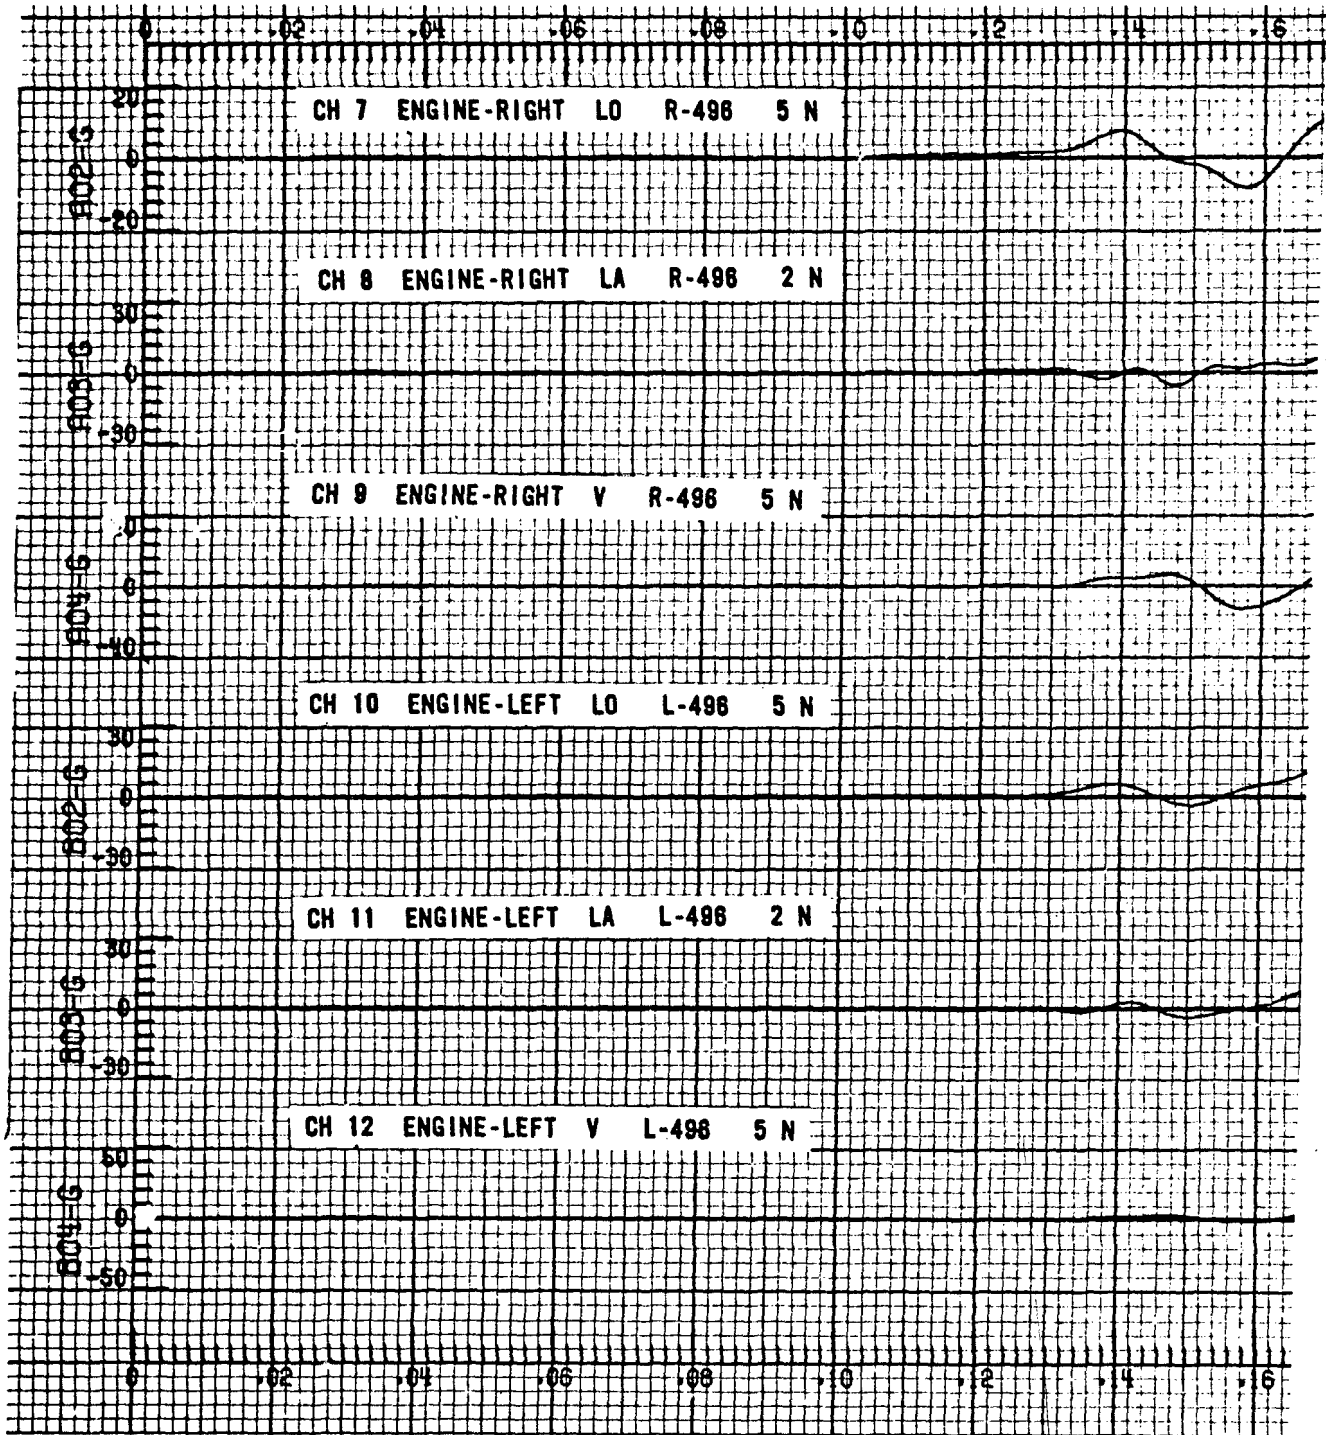
Figure 20. Engine decelerations.

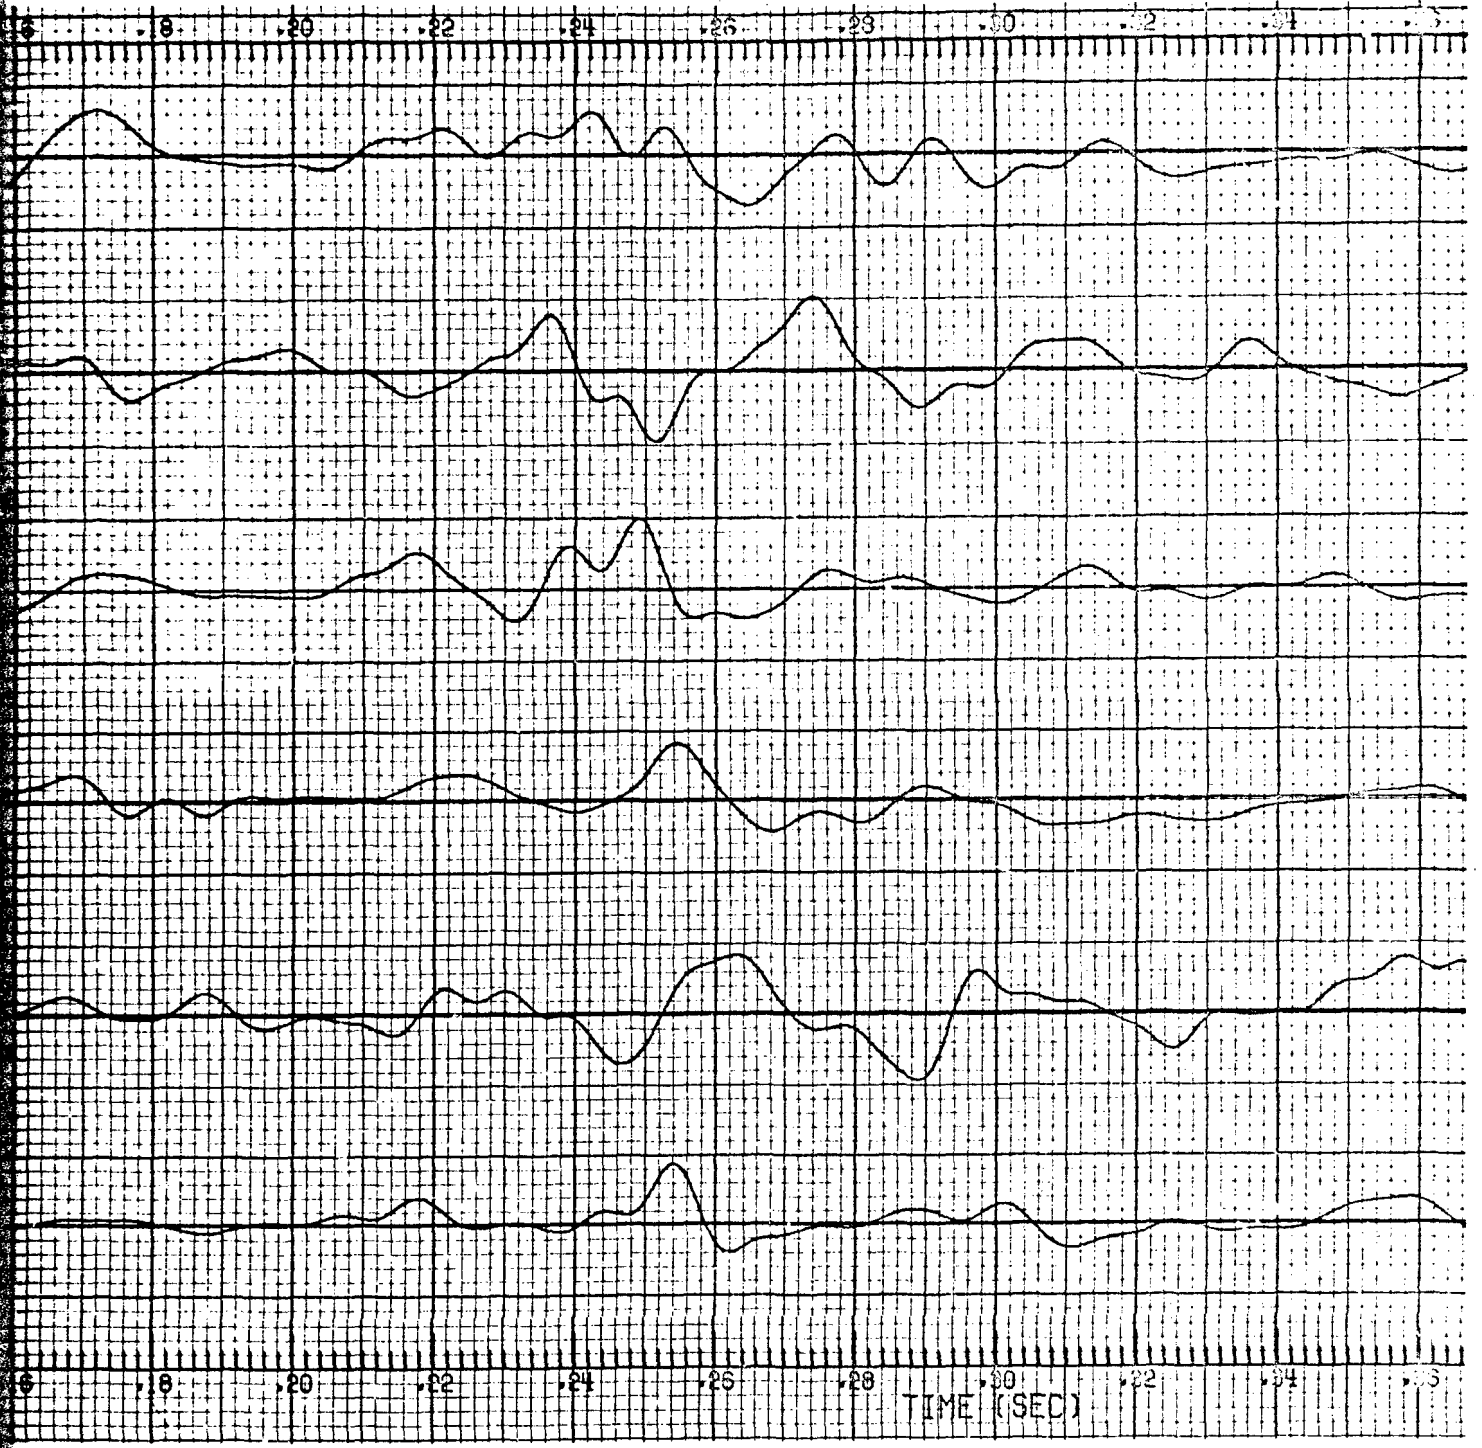
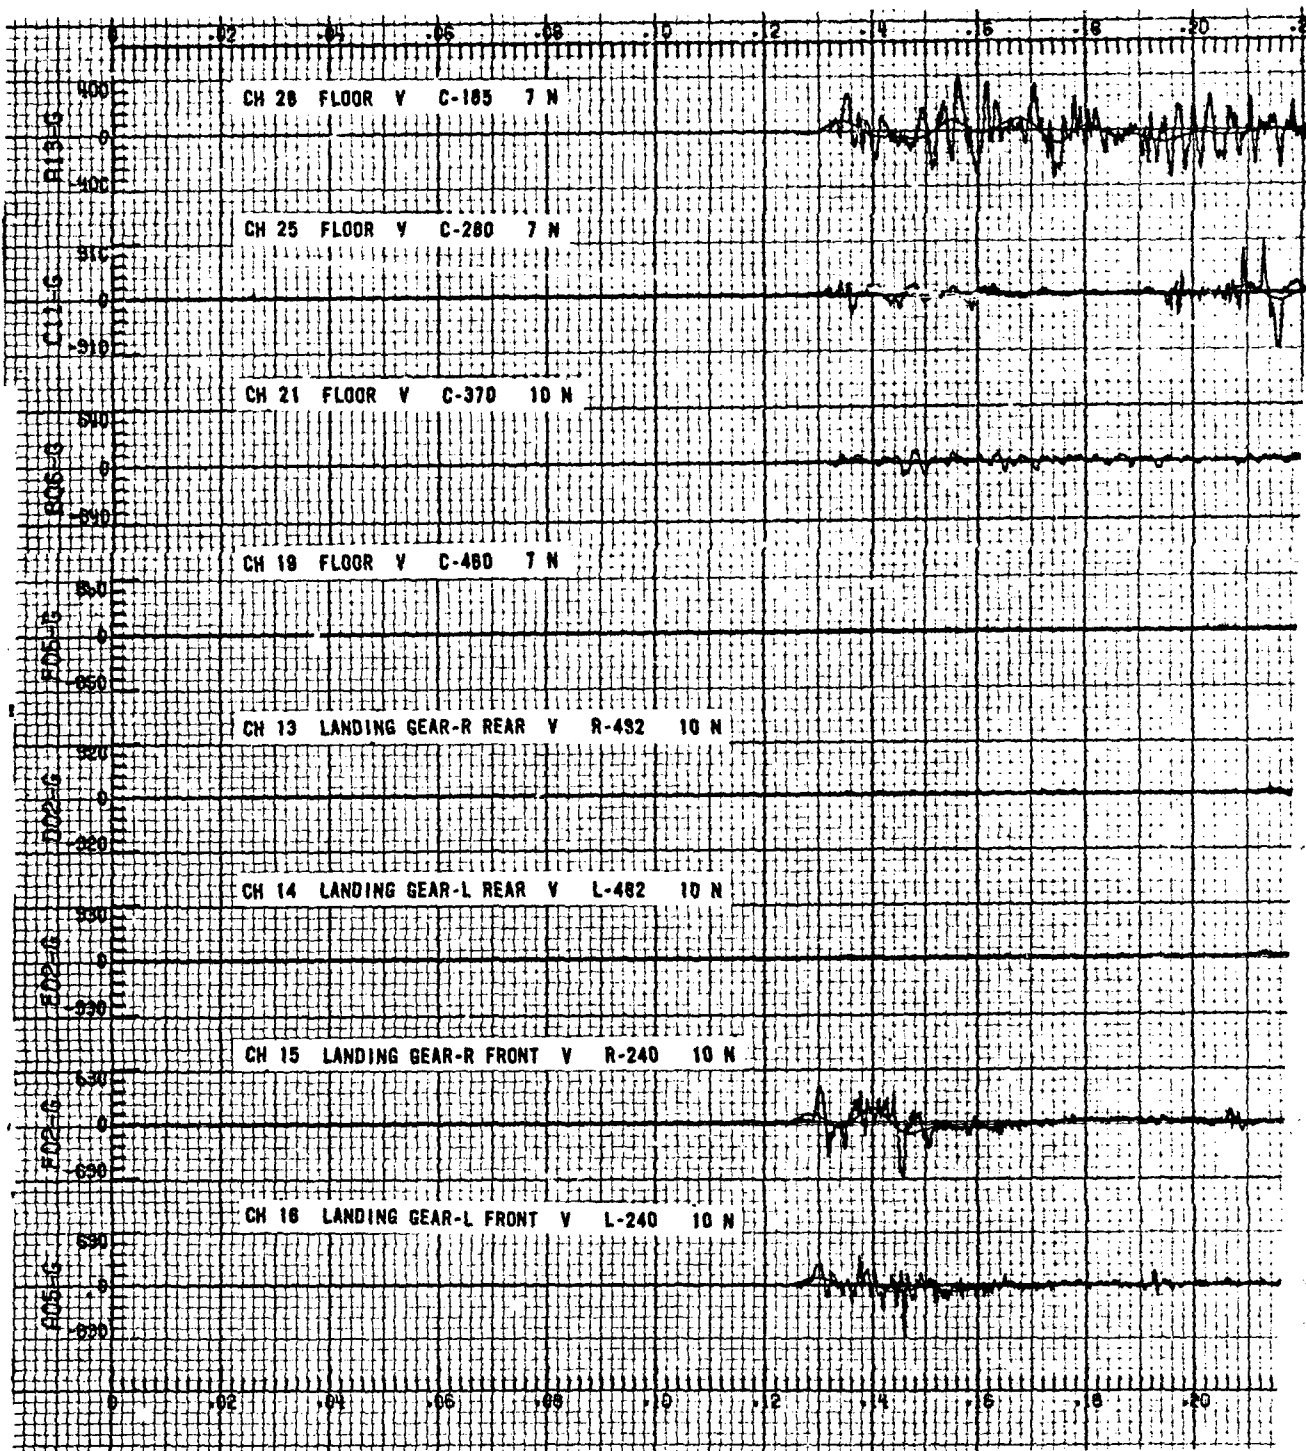
Figure 21. Cabin floor and landing gear attachment vertical decelerations (raw and 100 Hz filtered).

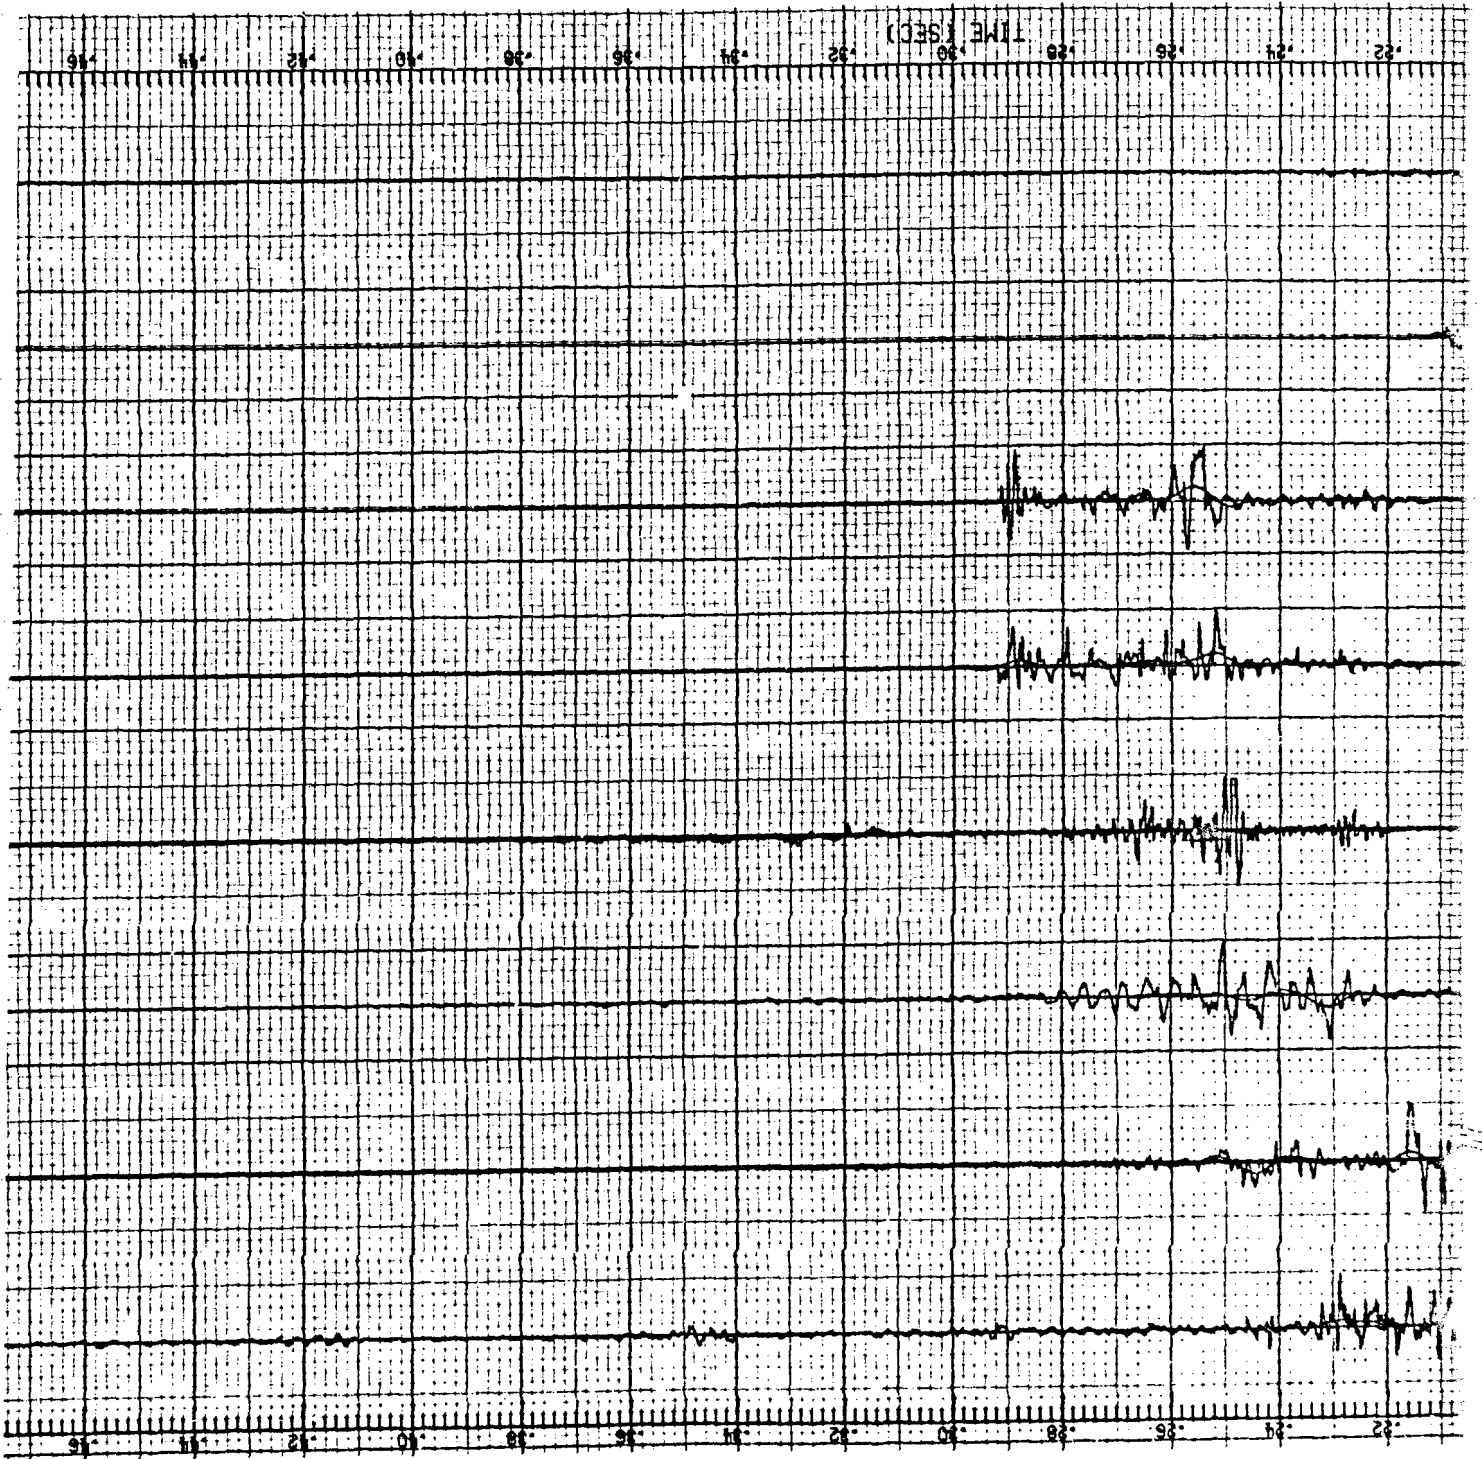
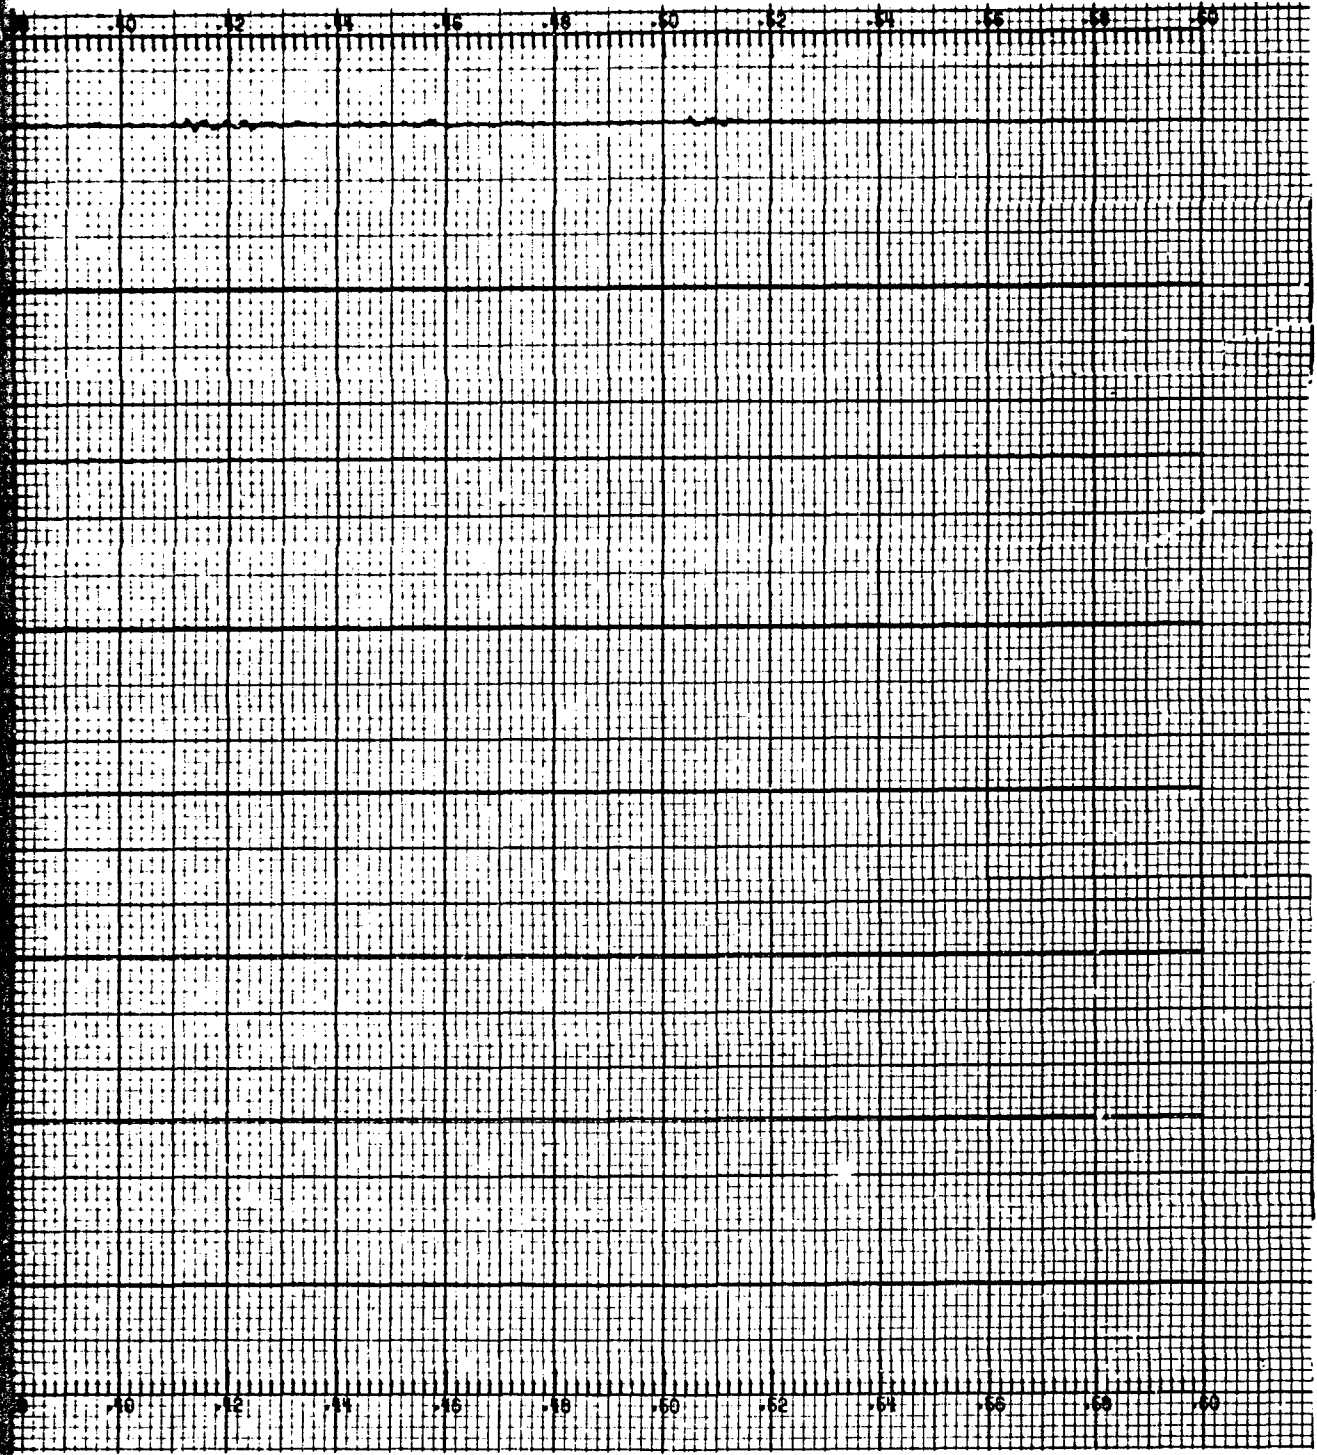
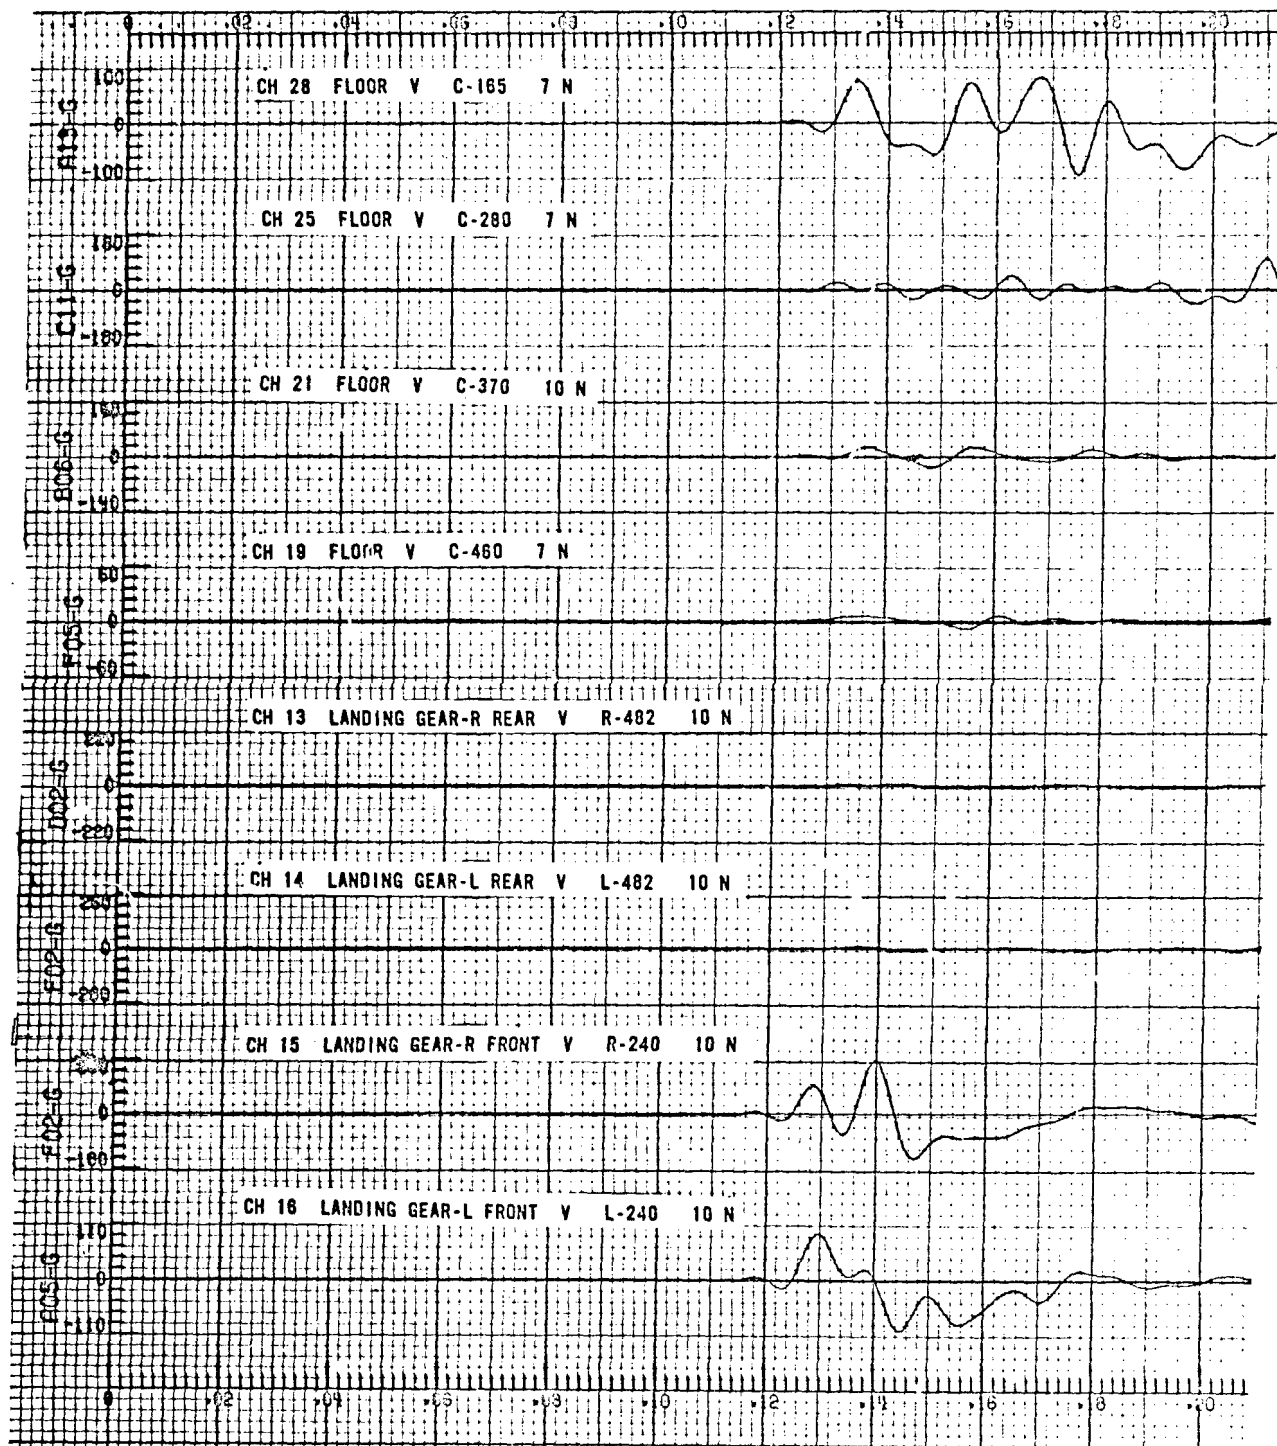
Figures 21, 22, 23, and 24 deal with the deceleration time history of the cabin floor and reflect the extent of the data reduction accomplished. This includes:

Figure 22. Cabin floor and landing gear attachment vertical decelerations (100 Hz filtered).
