USARTL-TR-78-22

# CH-47 CRASH TEST (T-40) STRUCTURAL, CARGO RESTRAINT, AND AIRCREW INFLATABLE RESTRAINT EXPERIMENTS

L. Burrows, R. Lane, J. McElhenney

April 1978

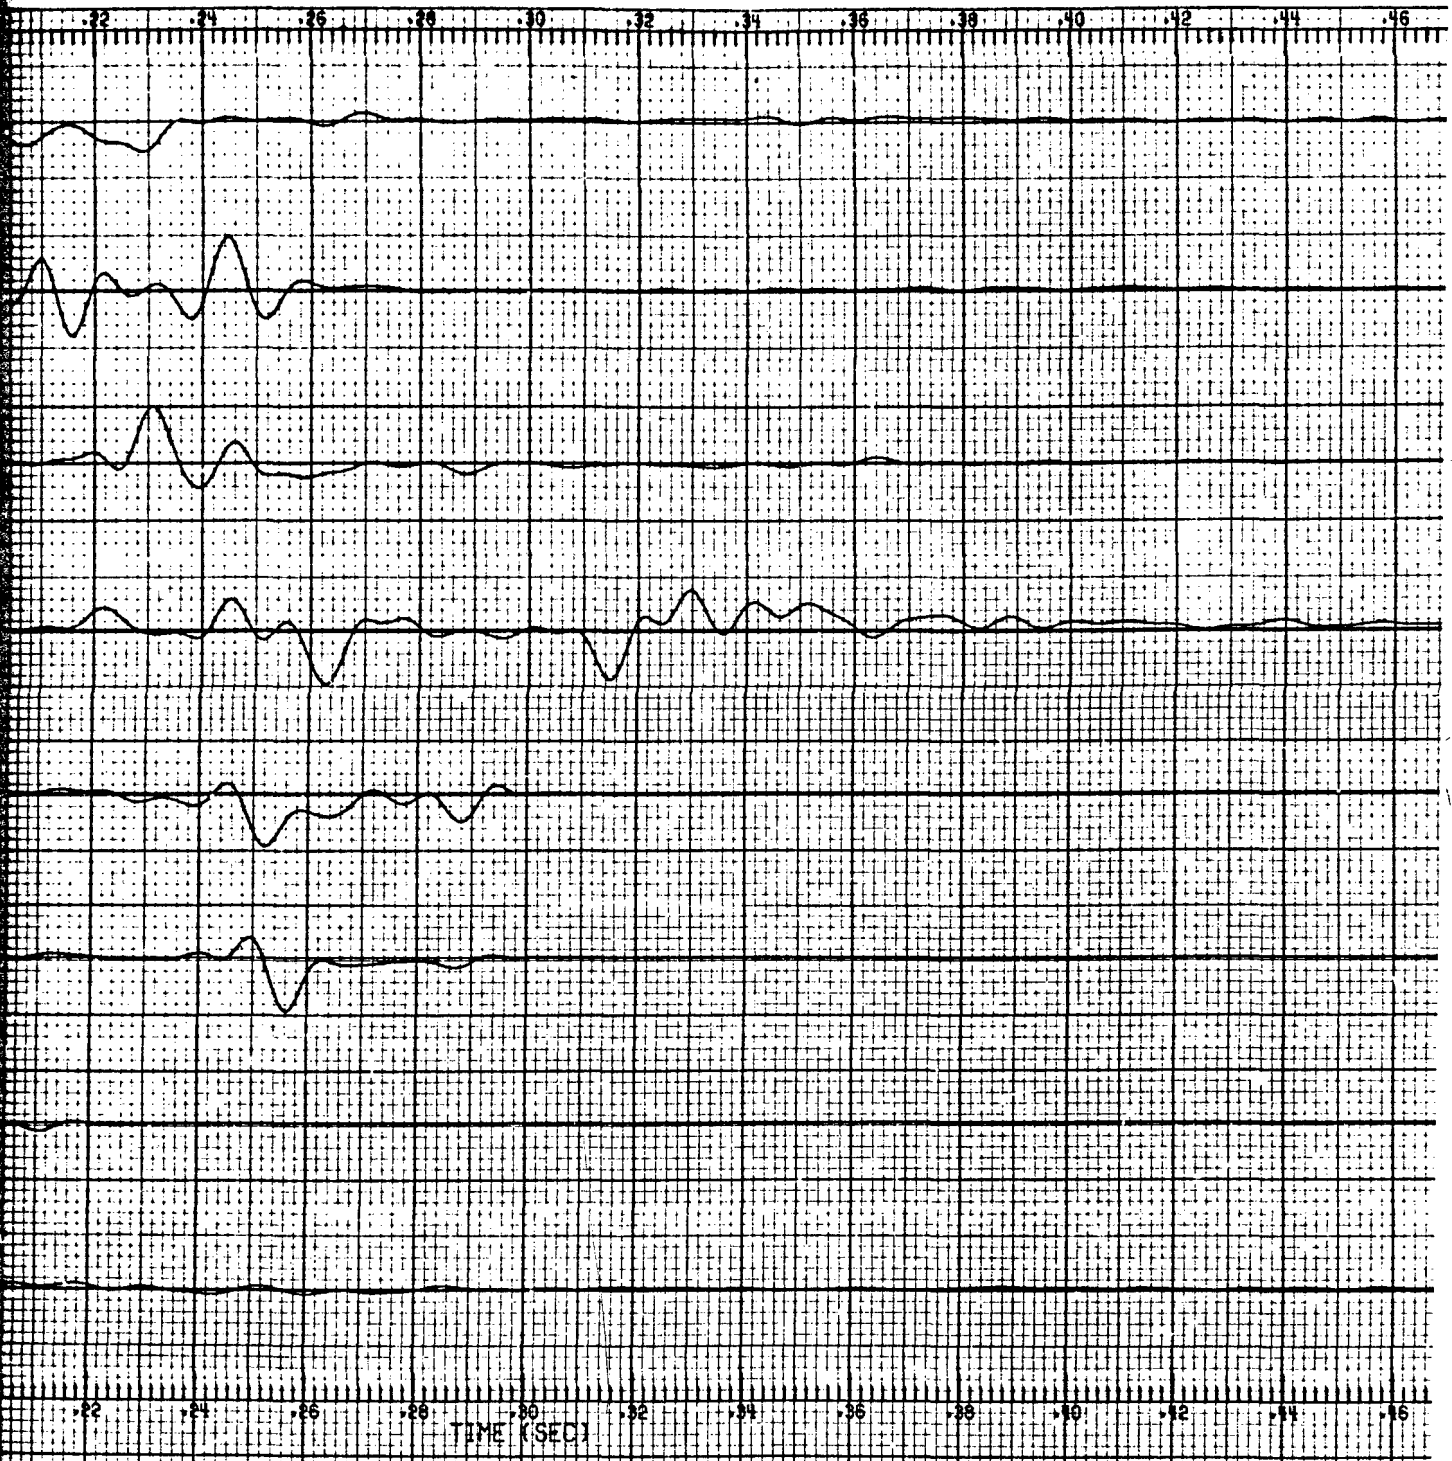
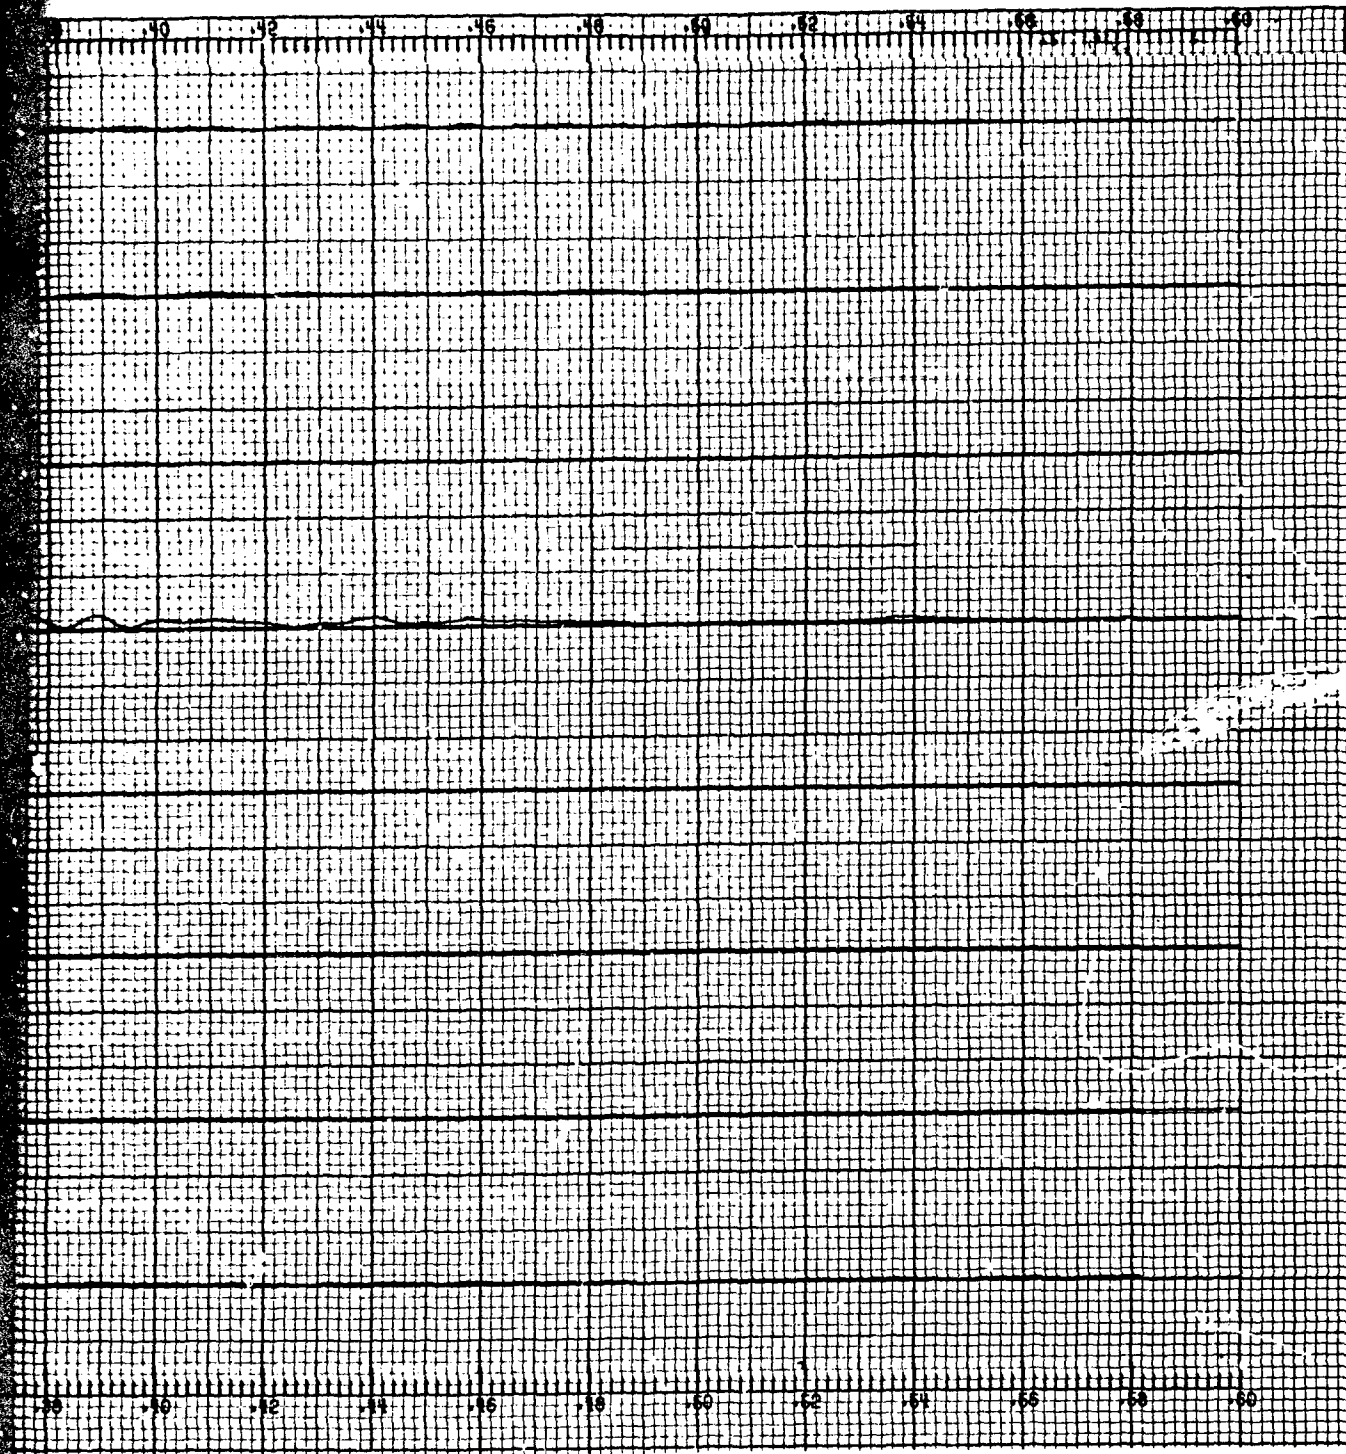
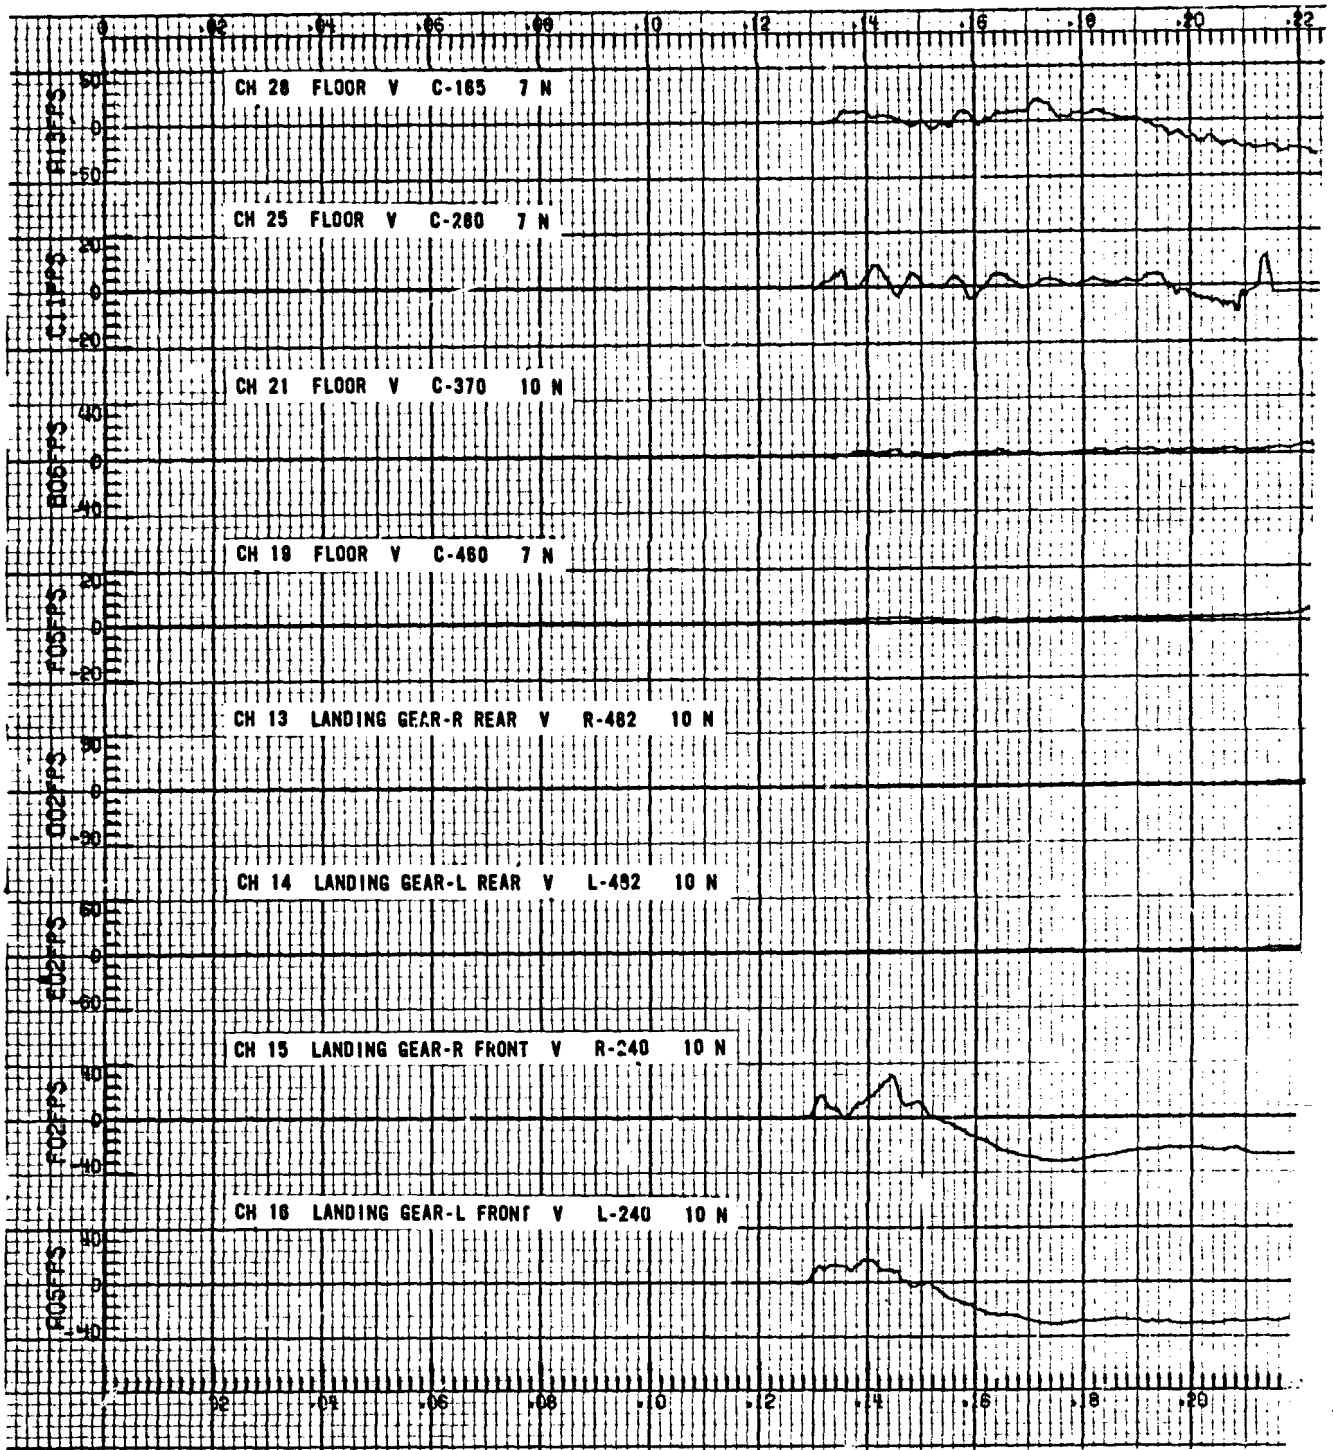
Figures 21, 22, 23, and 24 deal with the deceleration time history of the cabin floor and reflect the extent of the data reduction accomplished. This includes:

Figure 23. Cabin floor and landing gear attachment vertical decelerations (velocity integration).

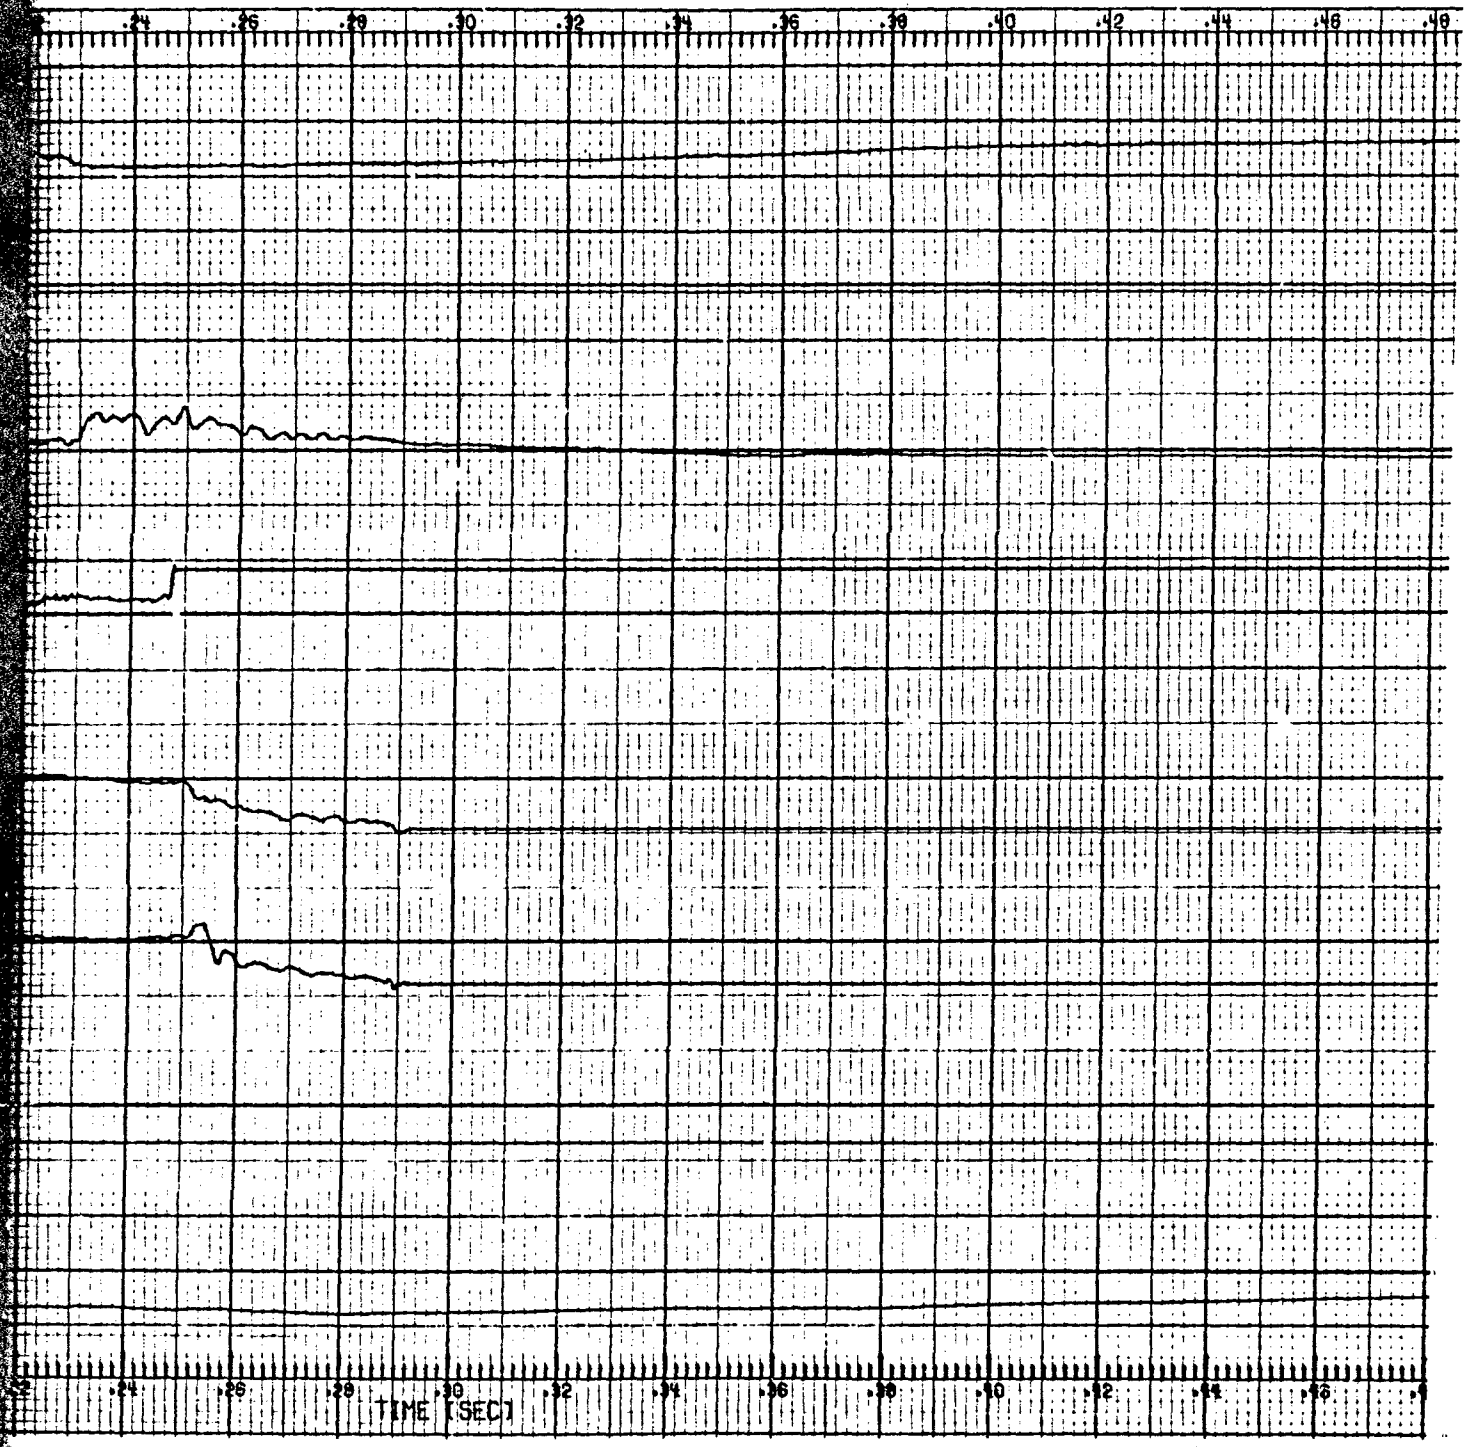
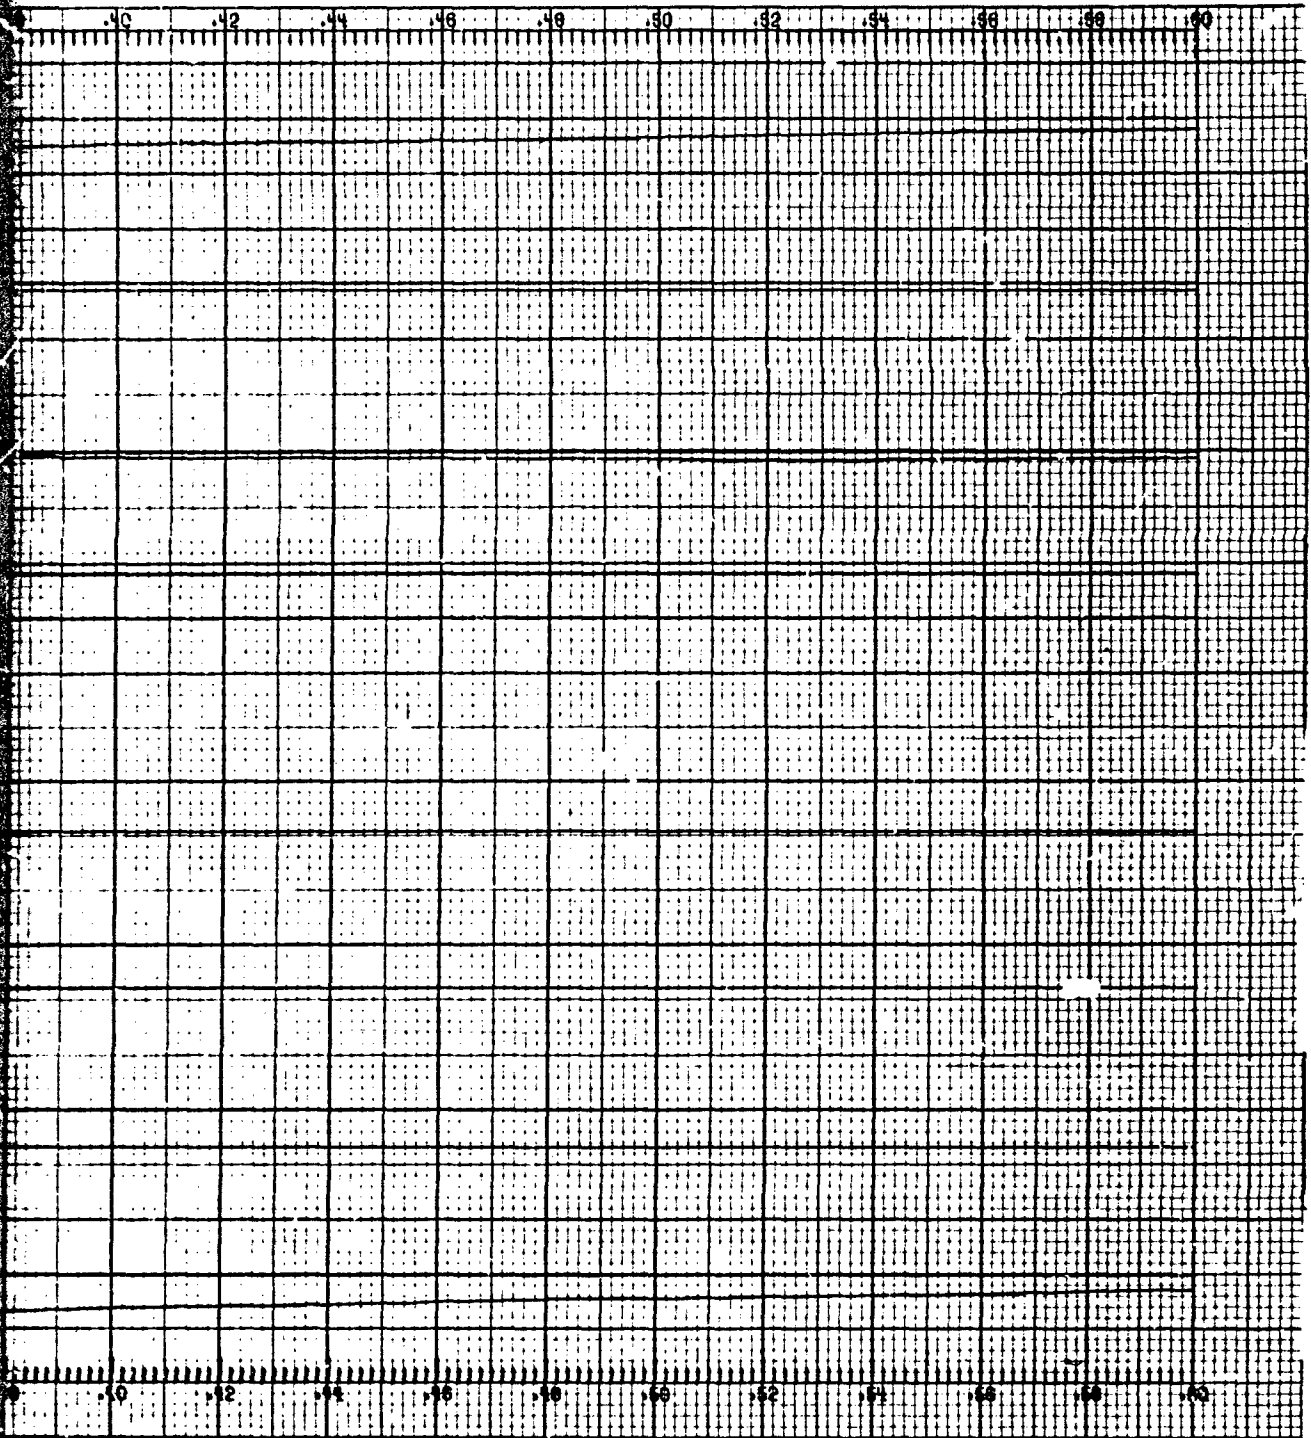
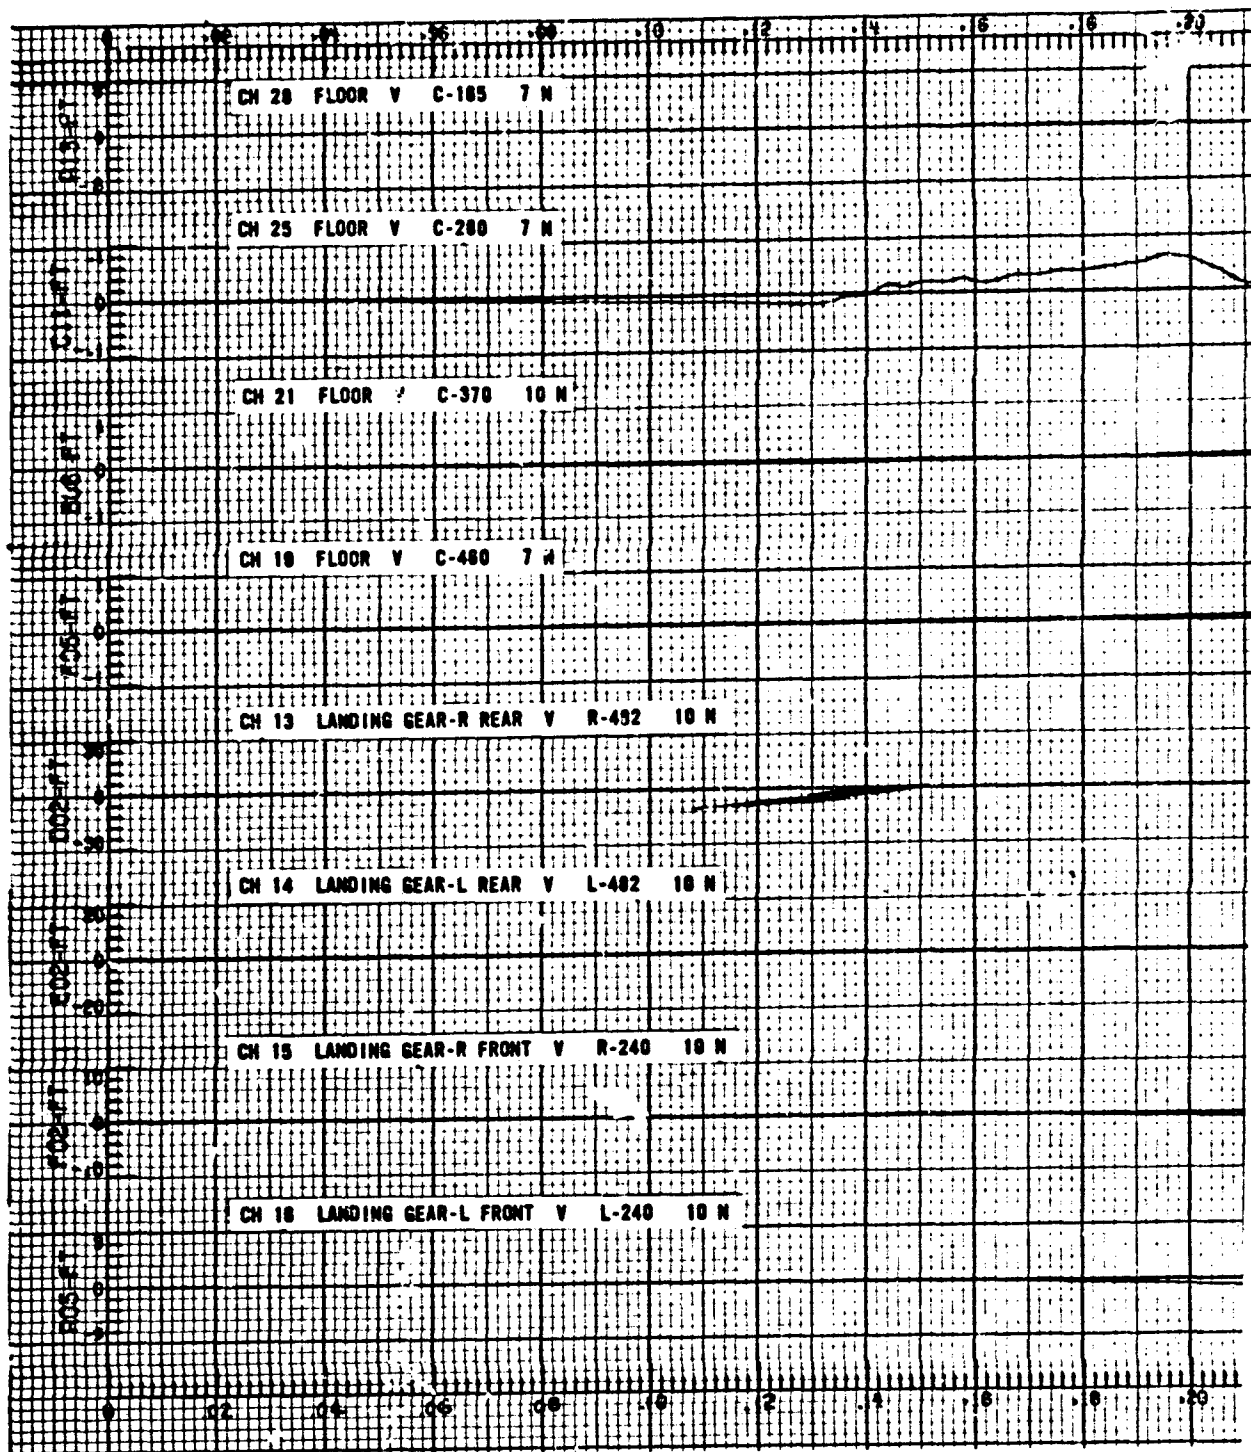
Figure 24. Cabin floor and landing gear attachment vertical decelerations
(displacement integration).

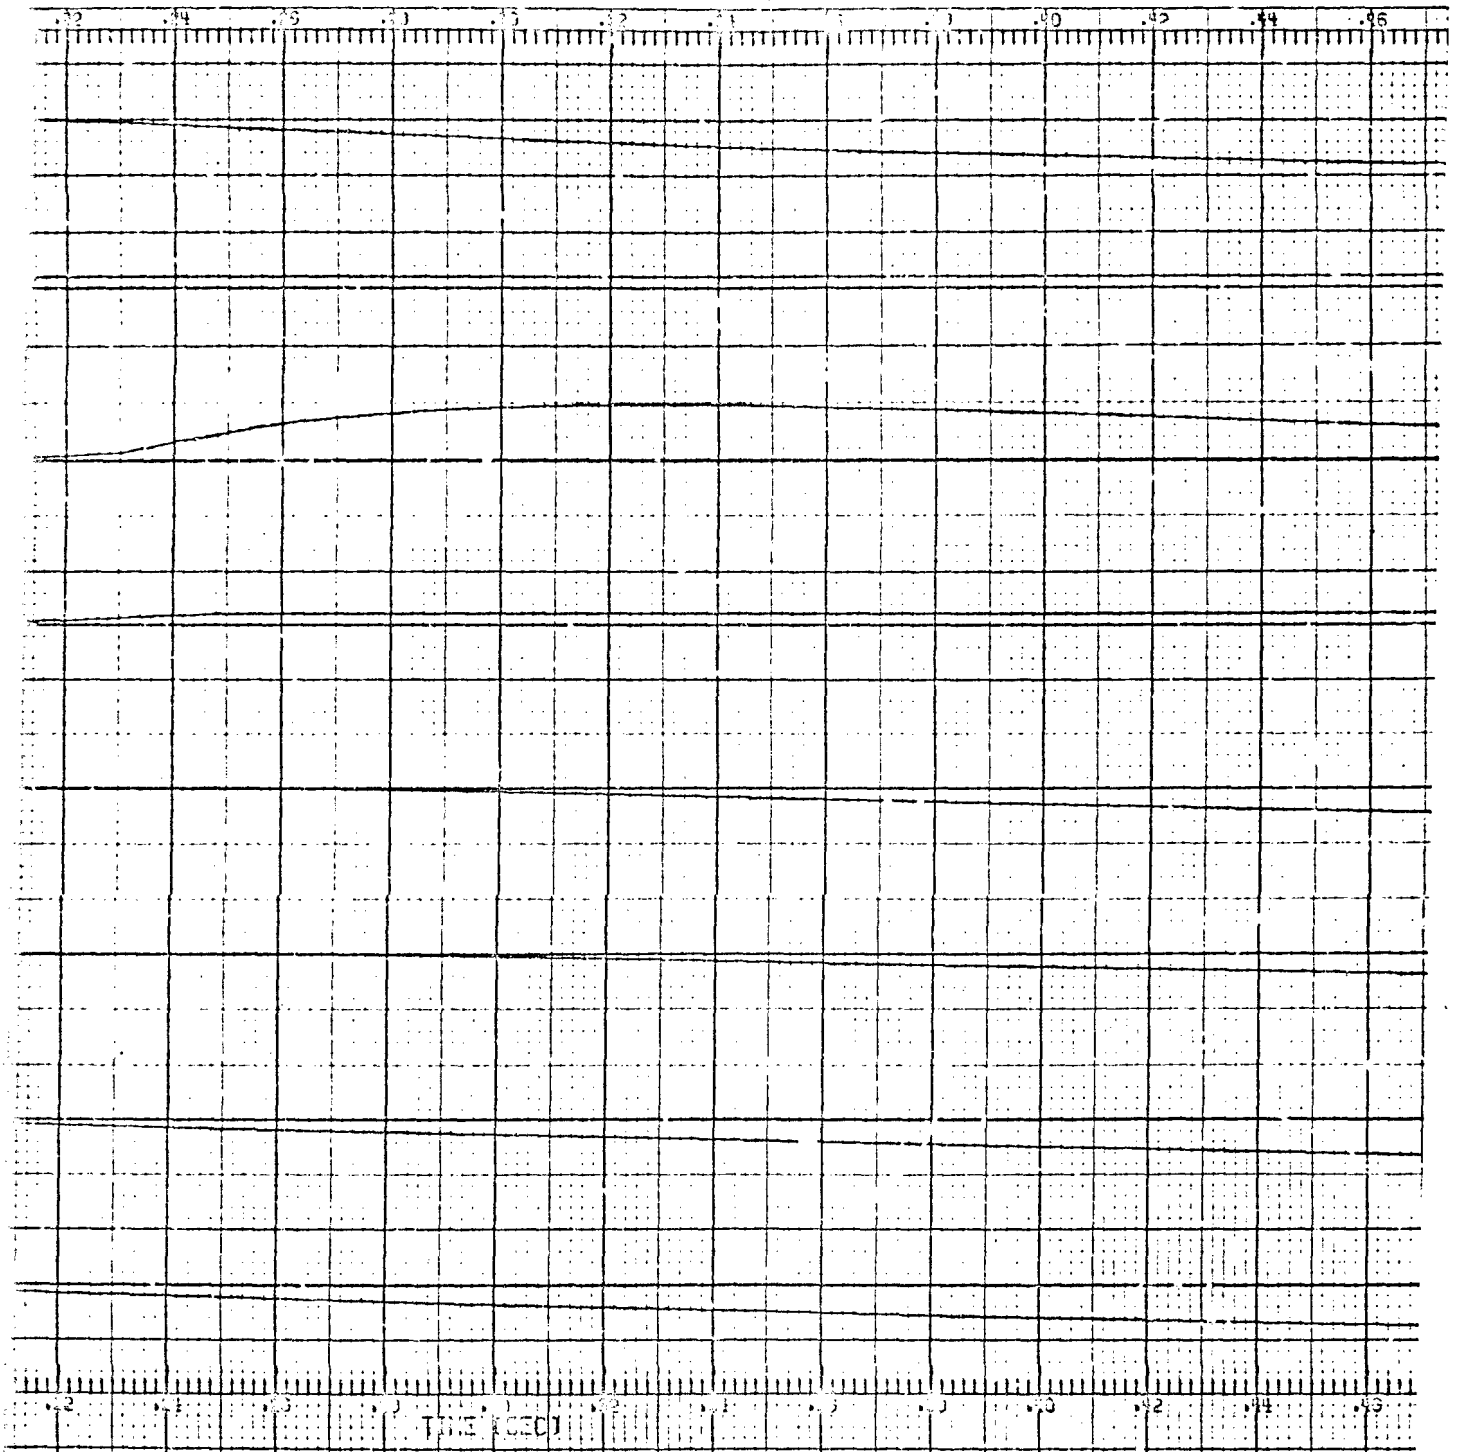
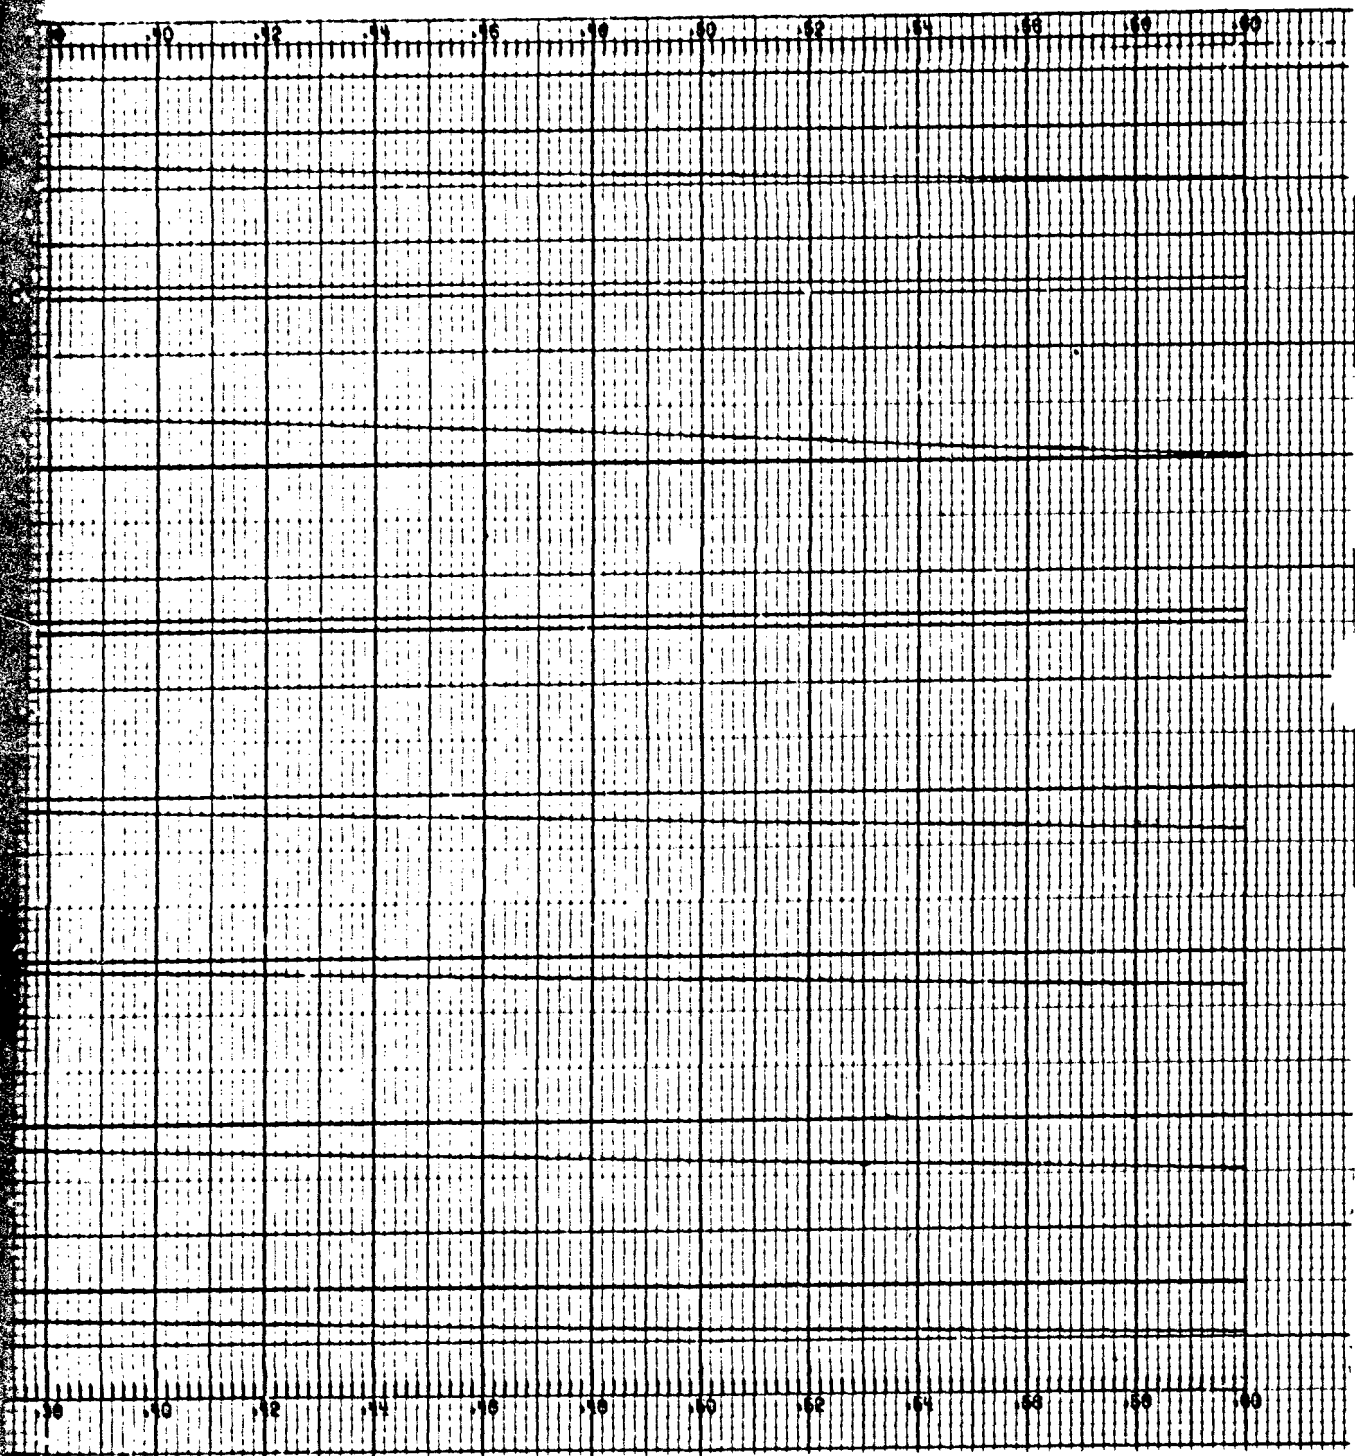
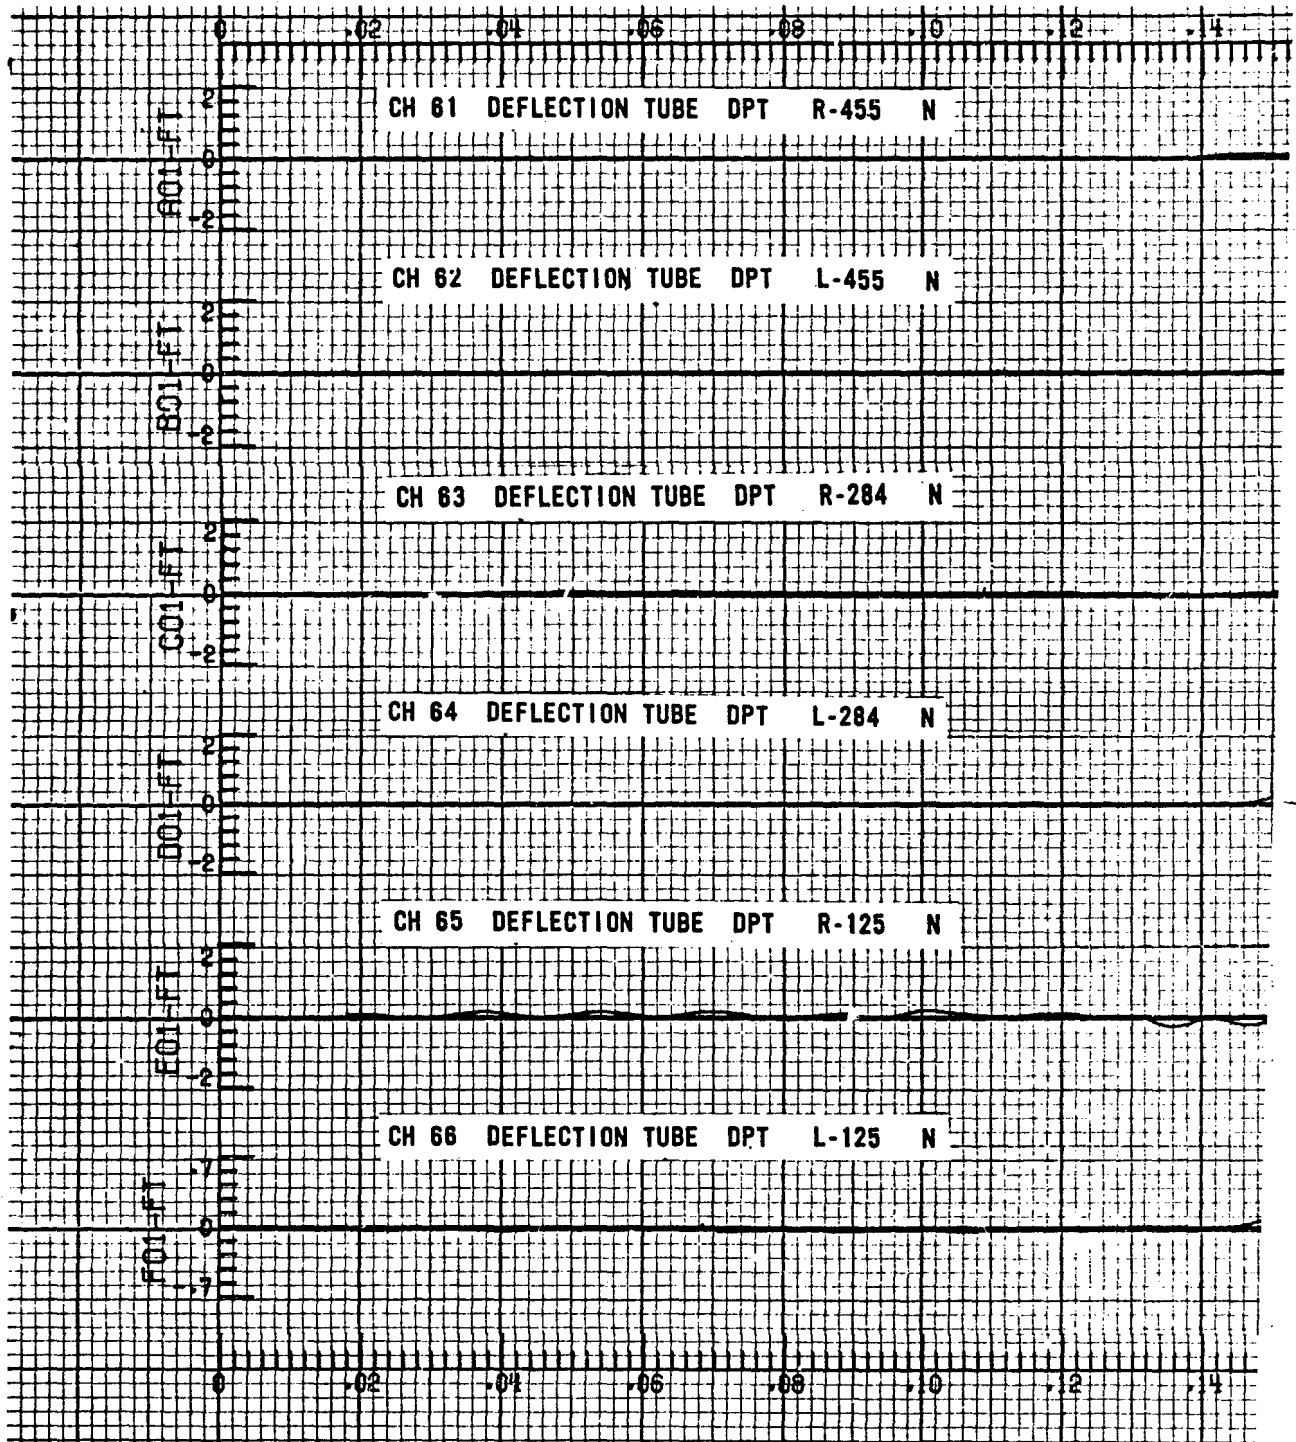
Figure 25 gives the time history recording of cabin height reduction measured by the deflection tubes. Figure 26 presents the longitudinal deceleration time history at the cabin floor centerline for various stations. Also shown is the fuel cell hydraulic ram pressure at impact. These pressure transducers were destroyed just after impact.

Figure 25. Cabin height reduction.
