USARTL-TR-78-22

# CH-47 CRASH TEST (T-40) STRUCTURAL, CARGO RESTRAINT, AND AIRCREW INFLATABLE RESTRAINT EXPERIMENTS

L. Burrows, R. Lane, J. McElhenney

April 1978

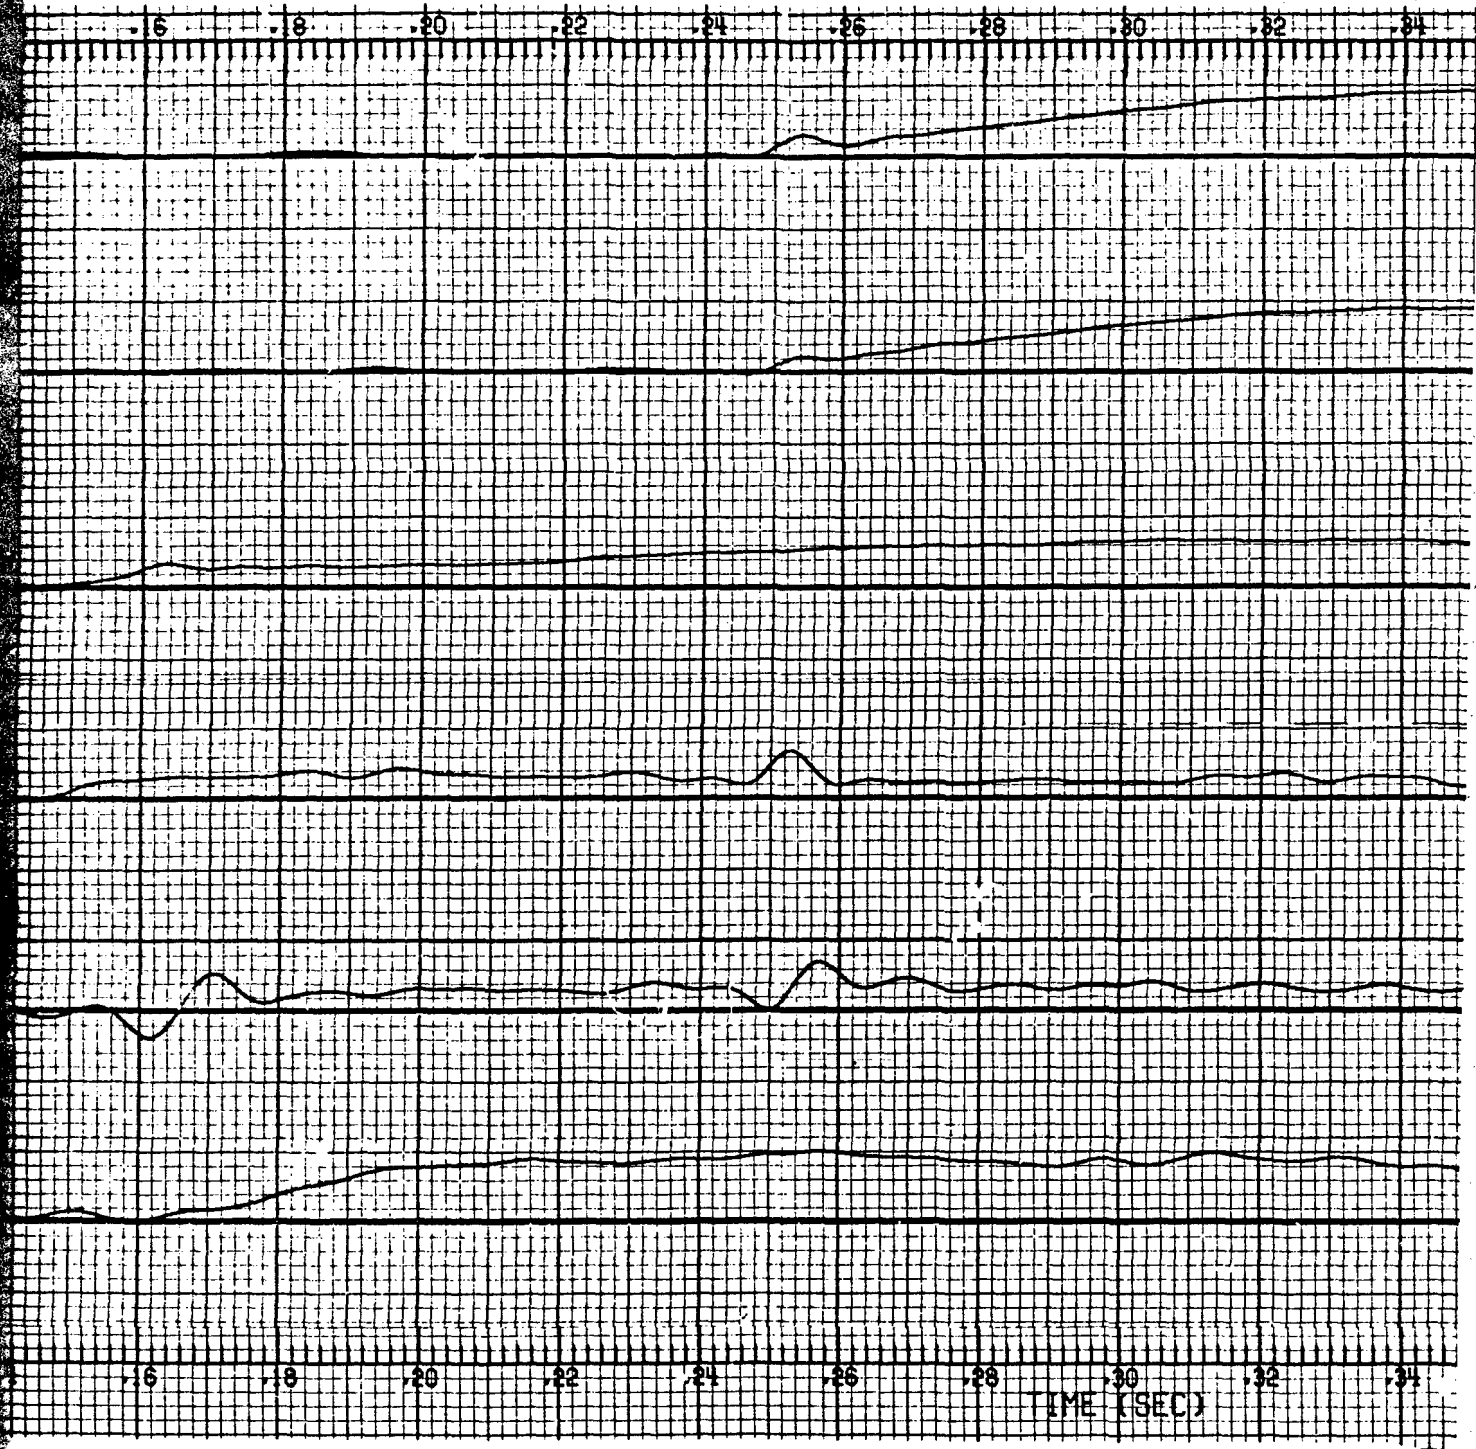
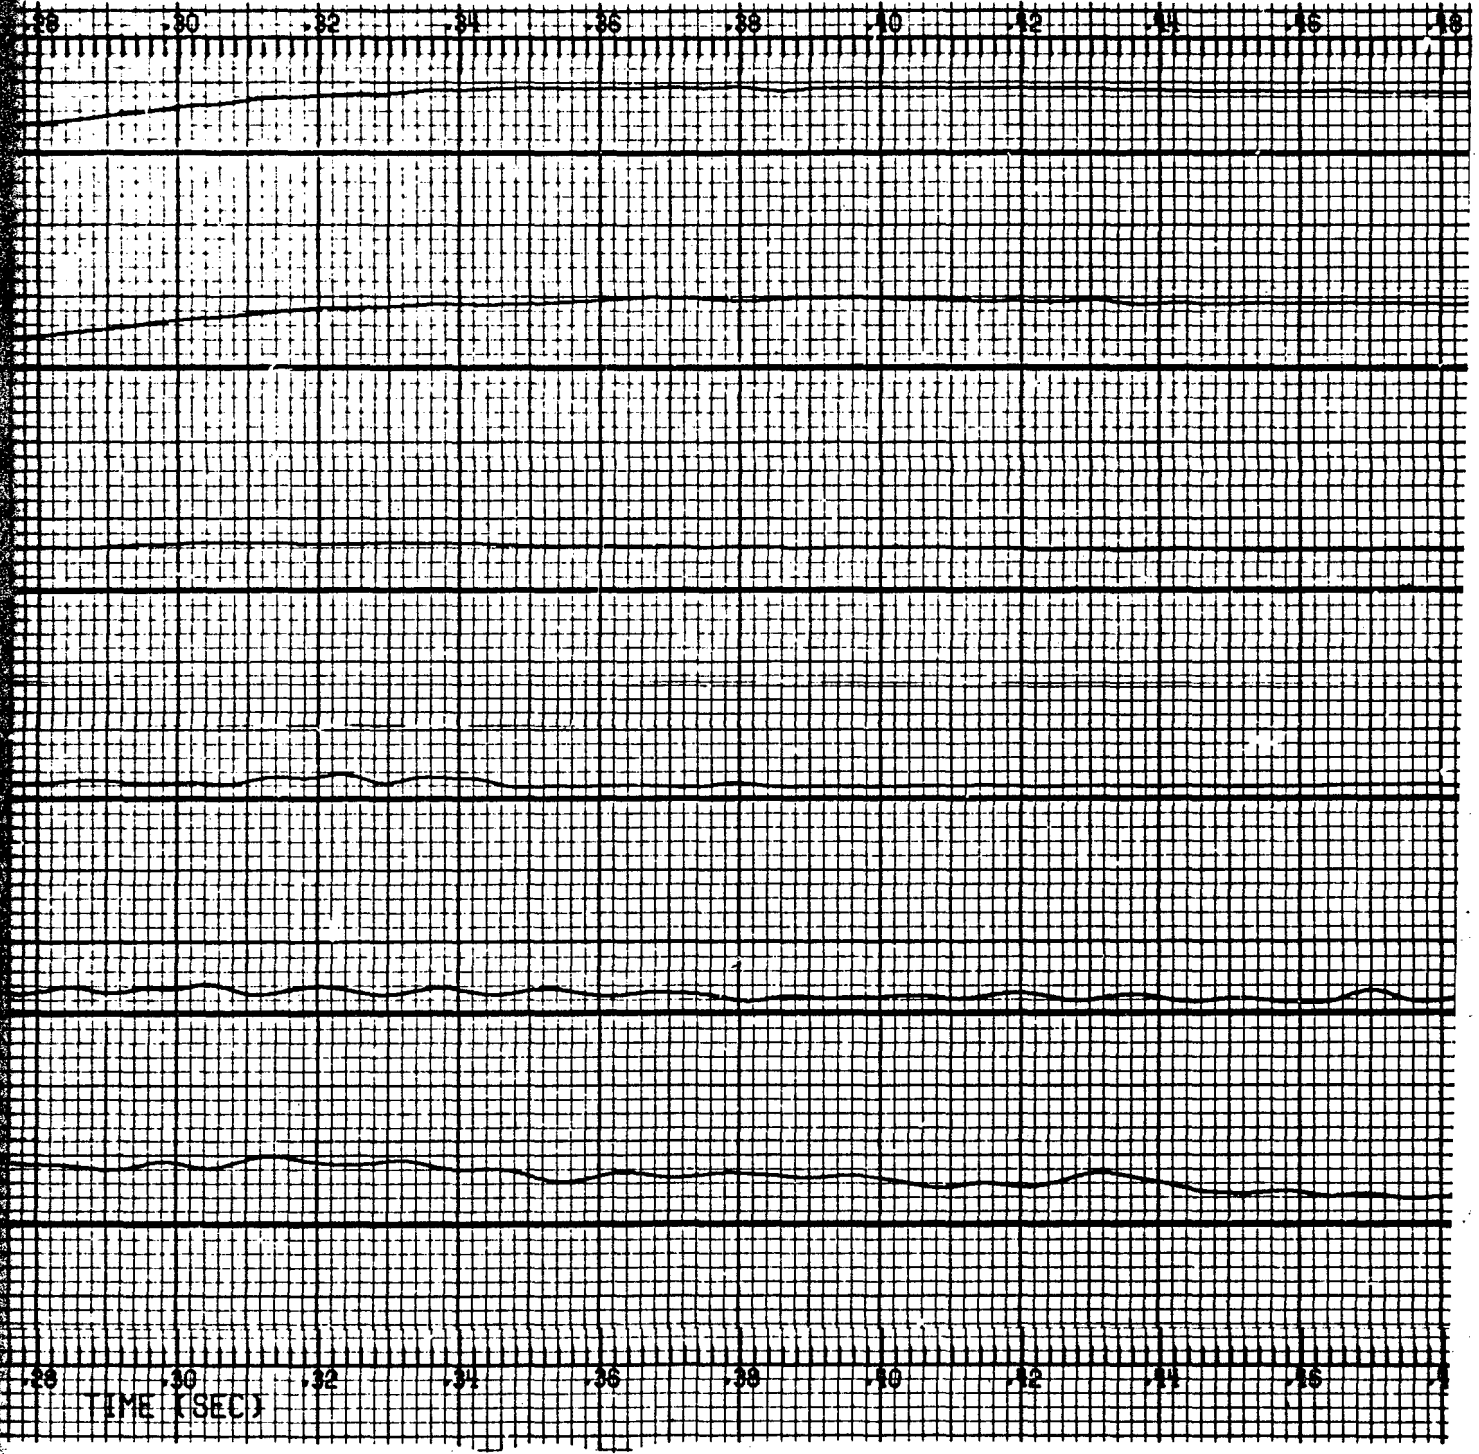
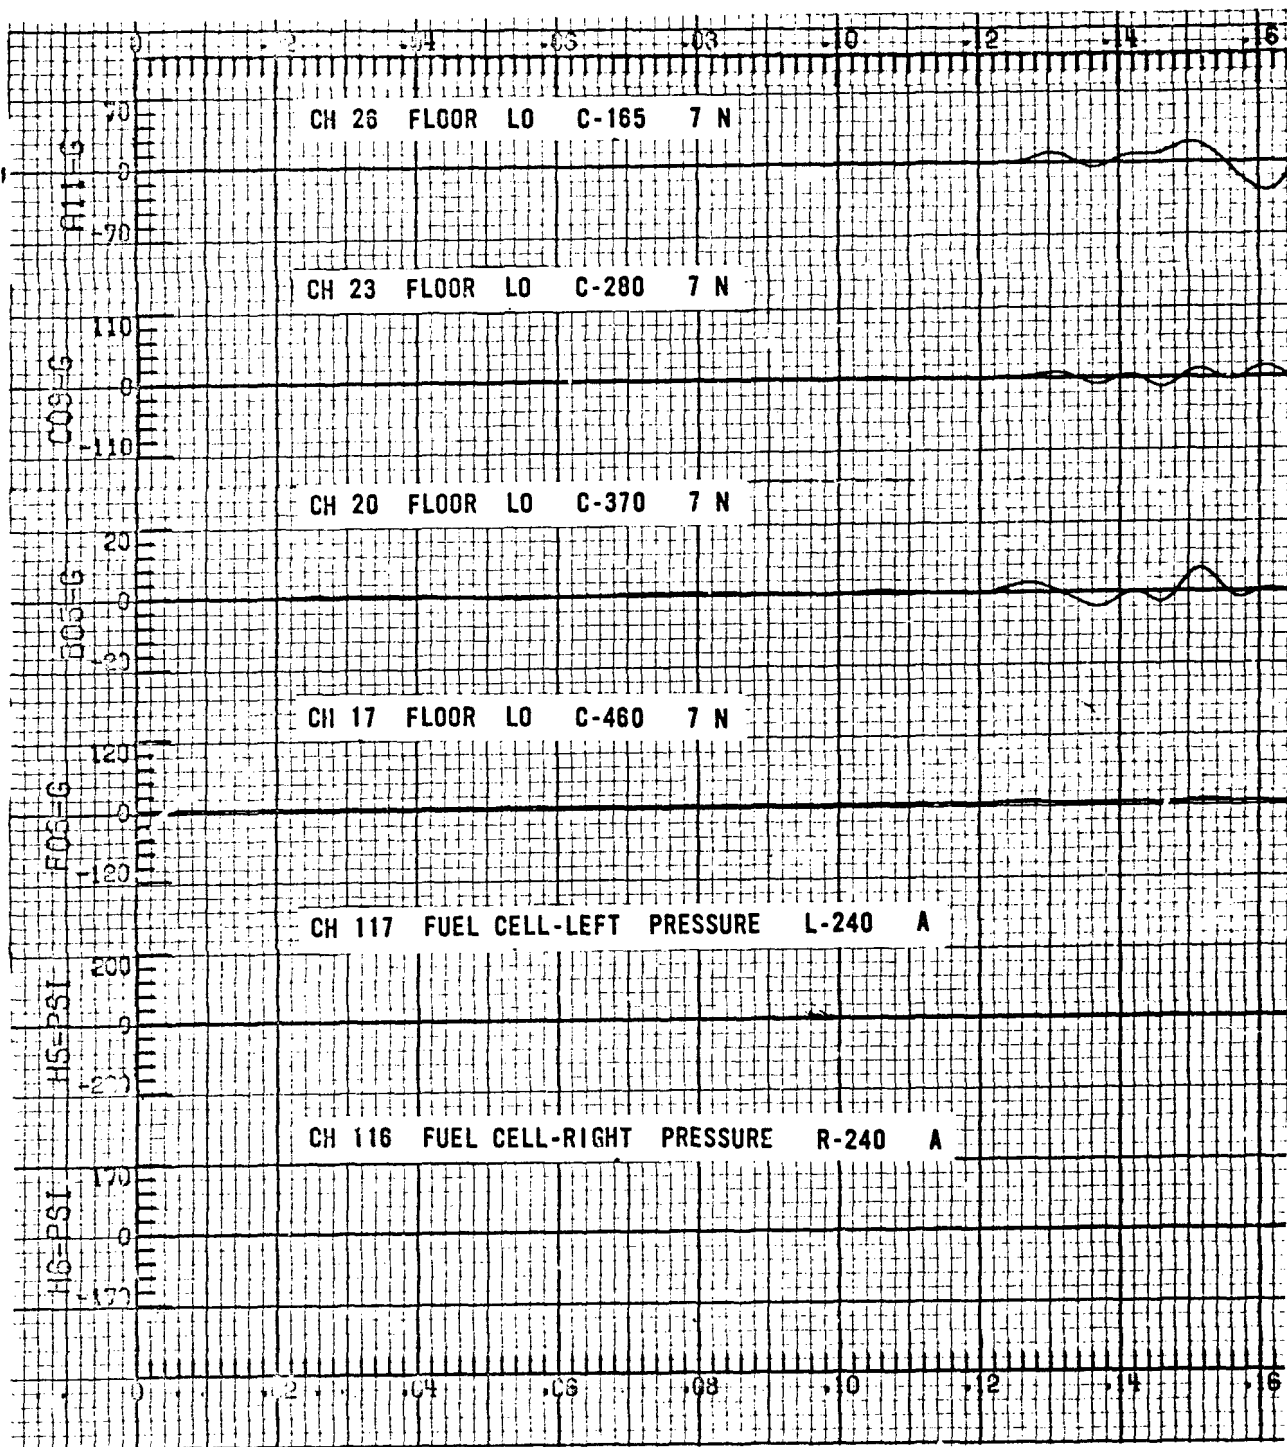
Figure 25 gives the time history recording of cabin height reduction measured by the deflection tubes. Figure 26 presents the longitudinal deceleration time history at the cabin floor centerline for various stations. Also shown is the fuel cell hydraulic ram pressure at impact. These pressure transducers were destroyed just after impact.

Figure 26. Cabin floor longitudinal decelerations and fuel cell pressure.

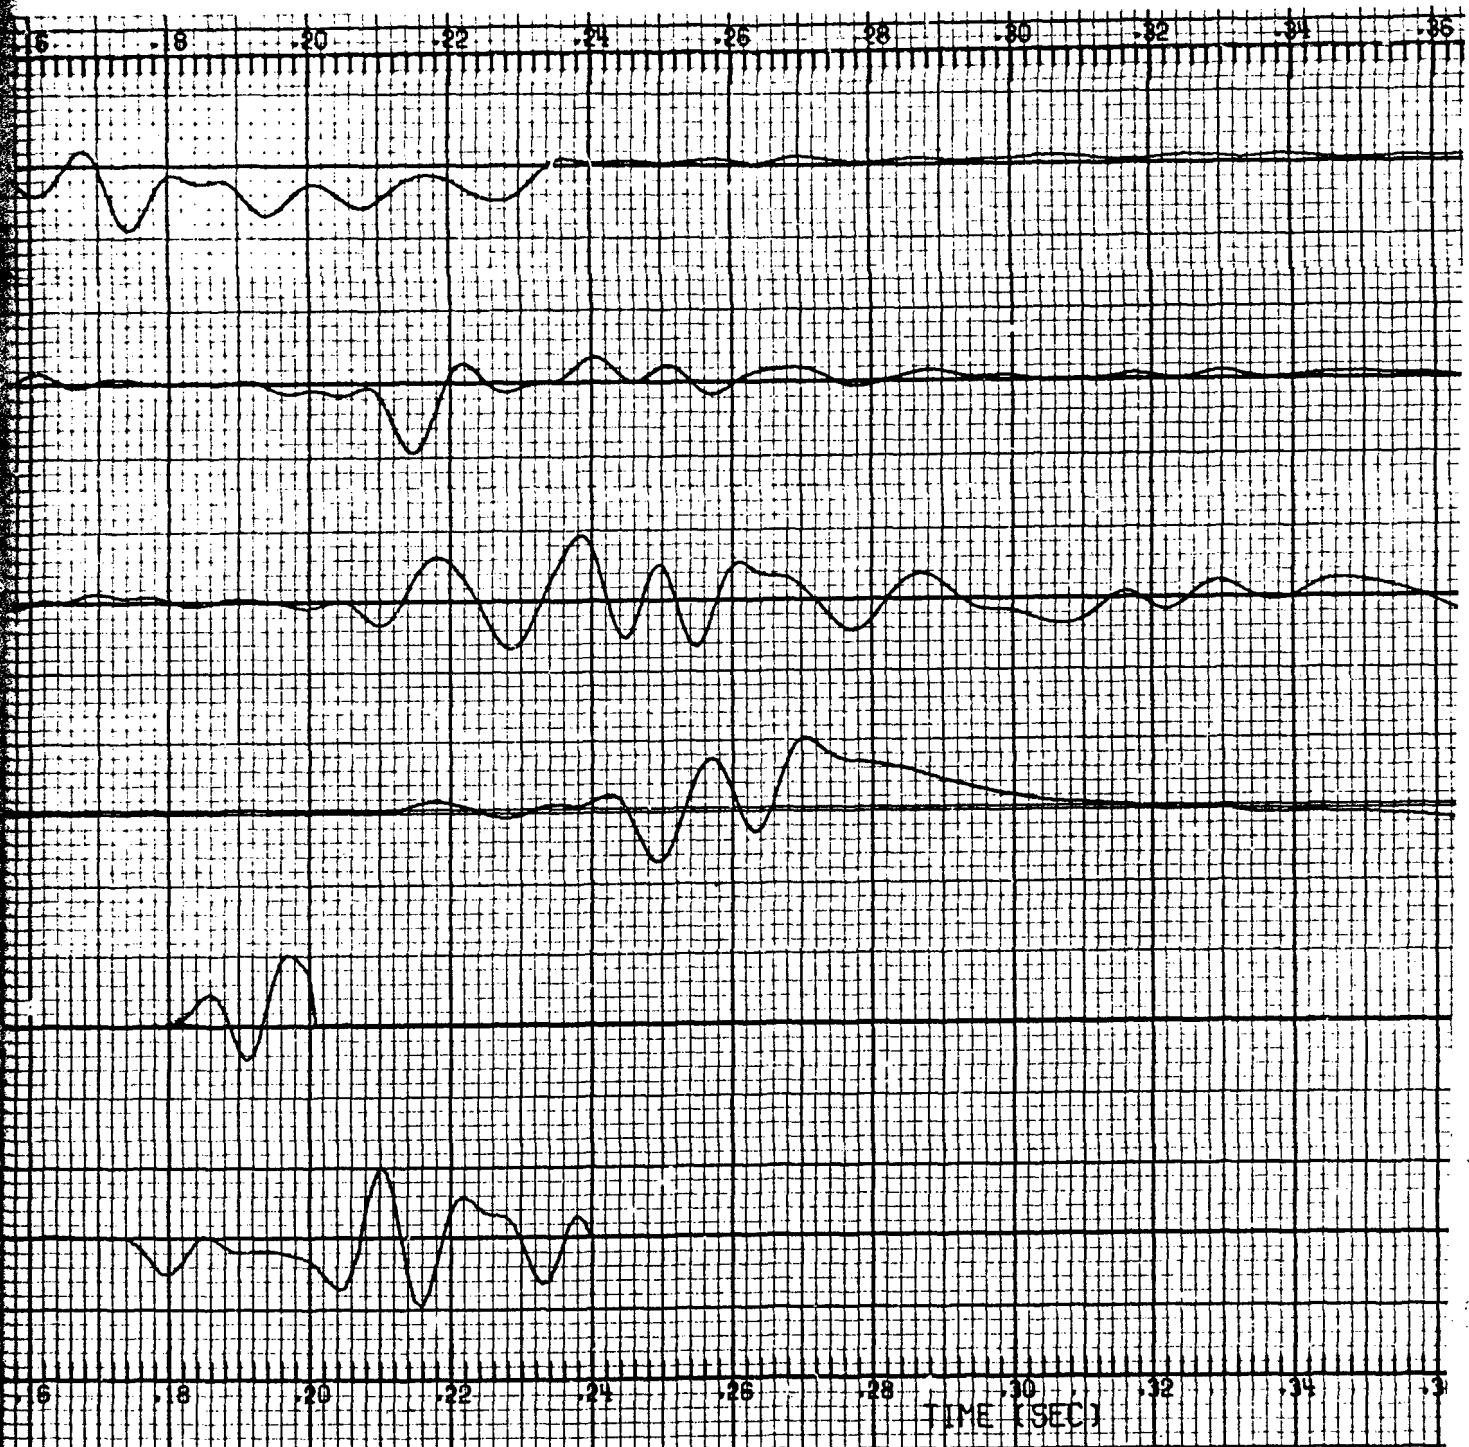
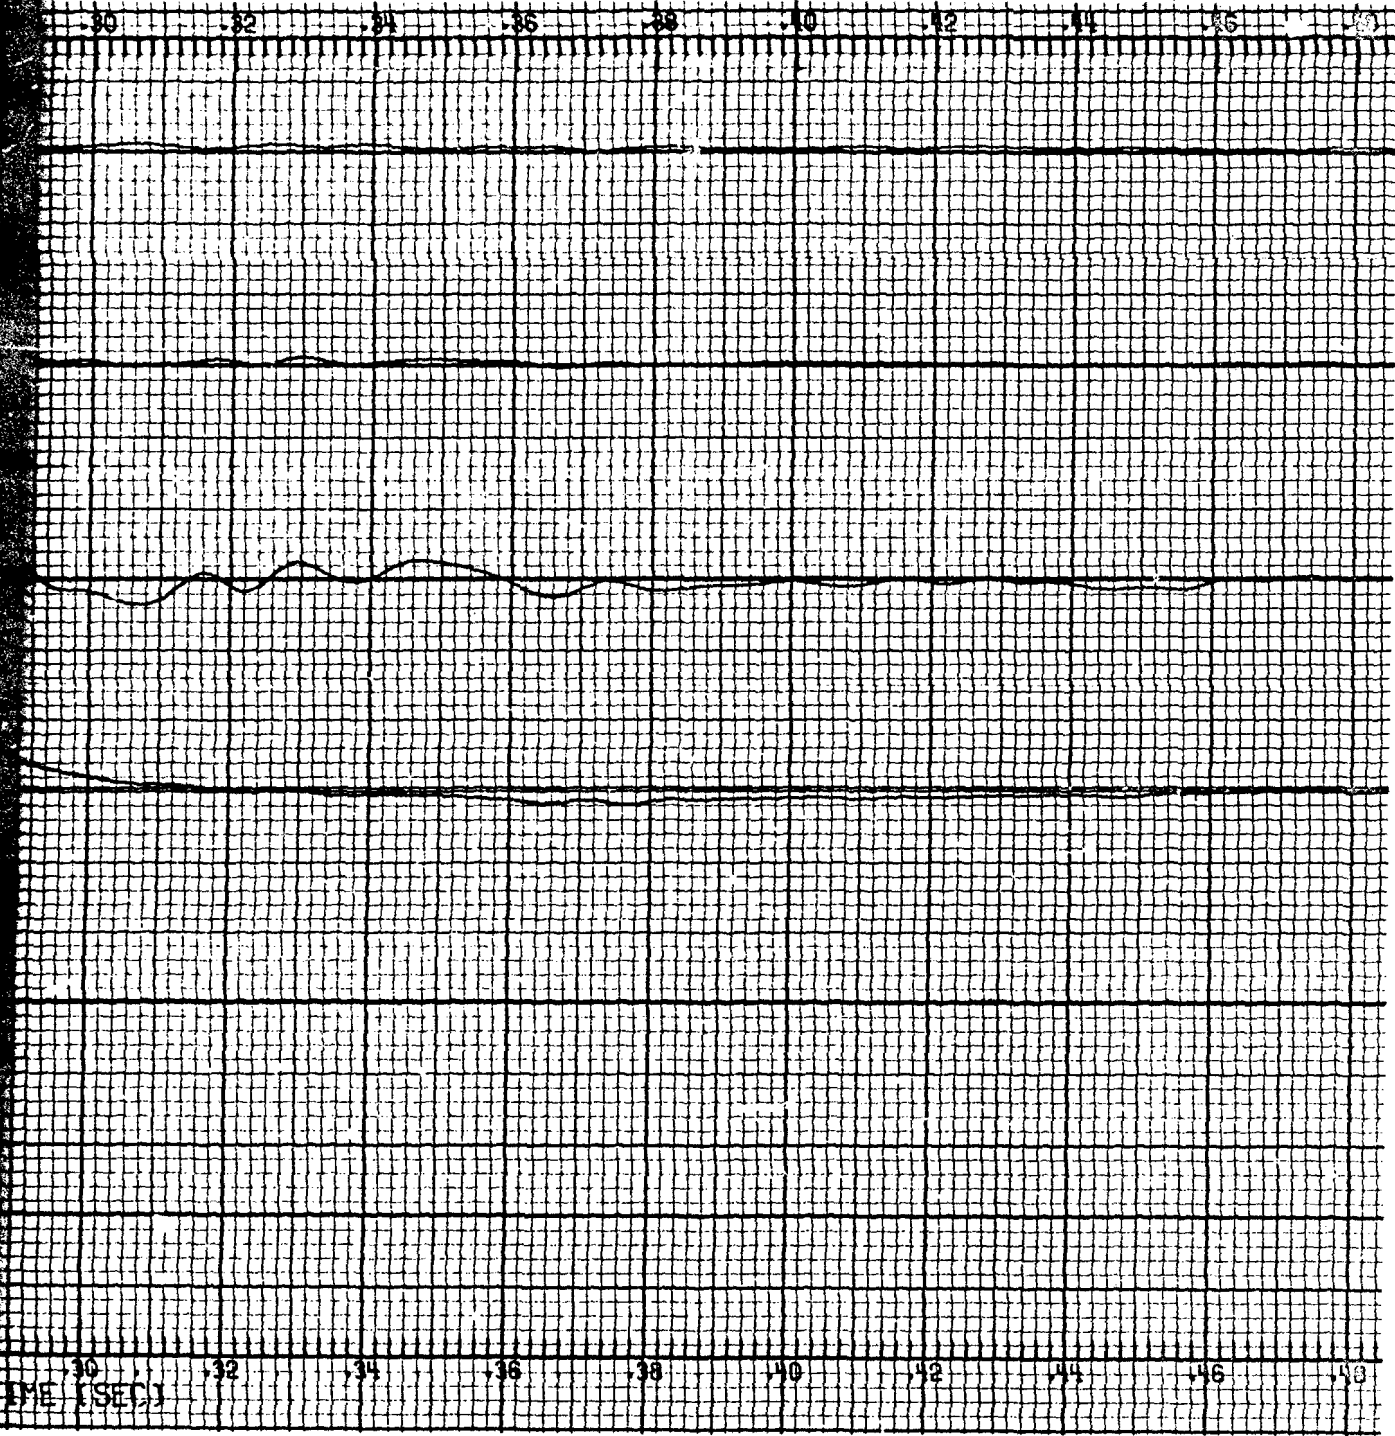
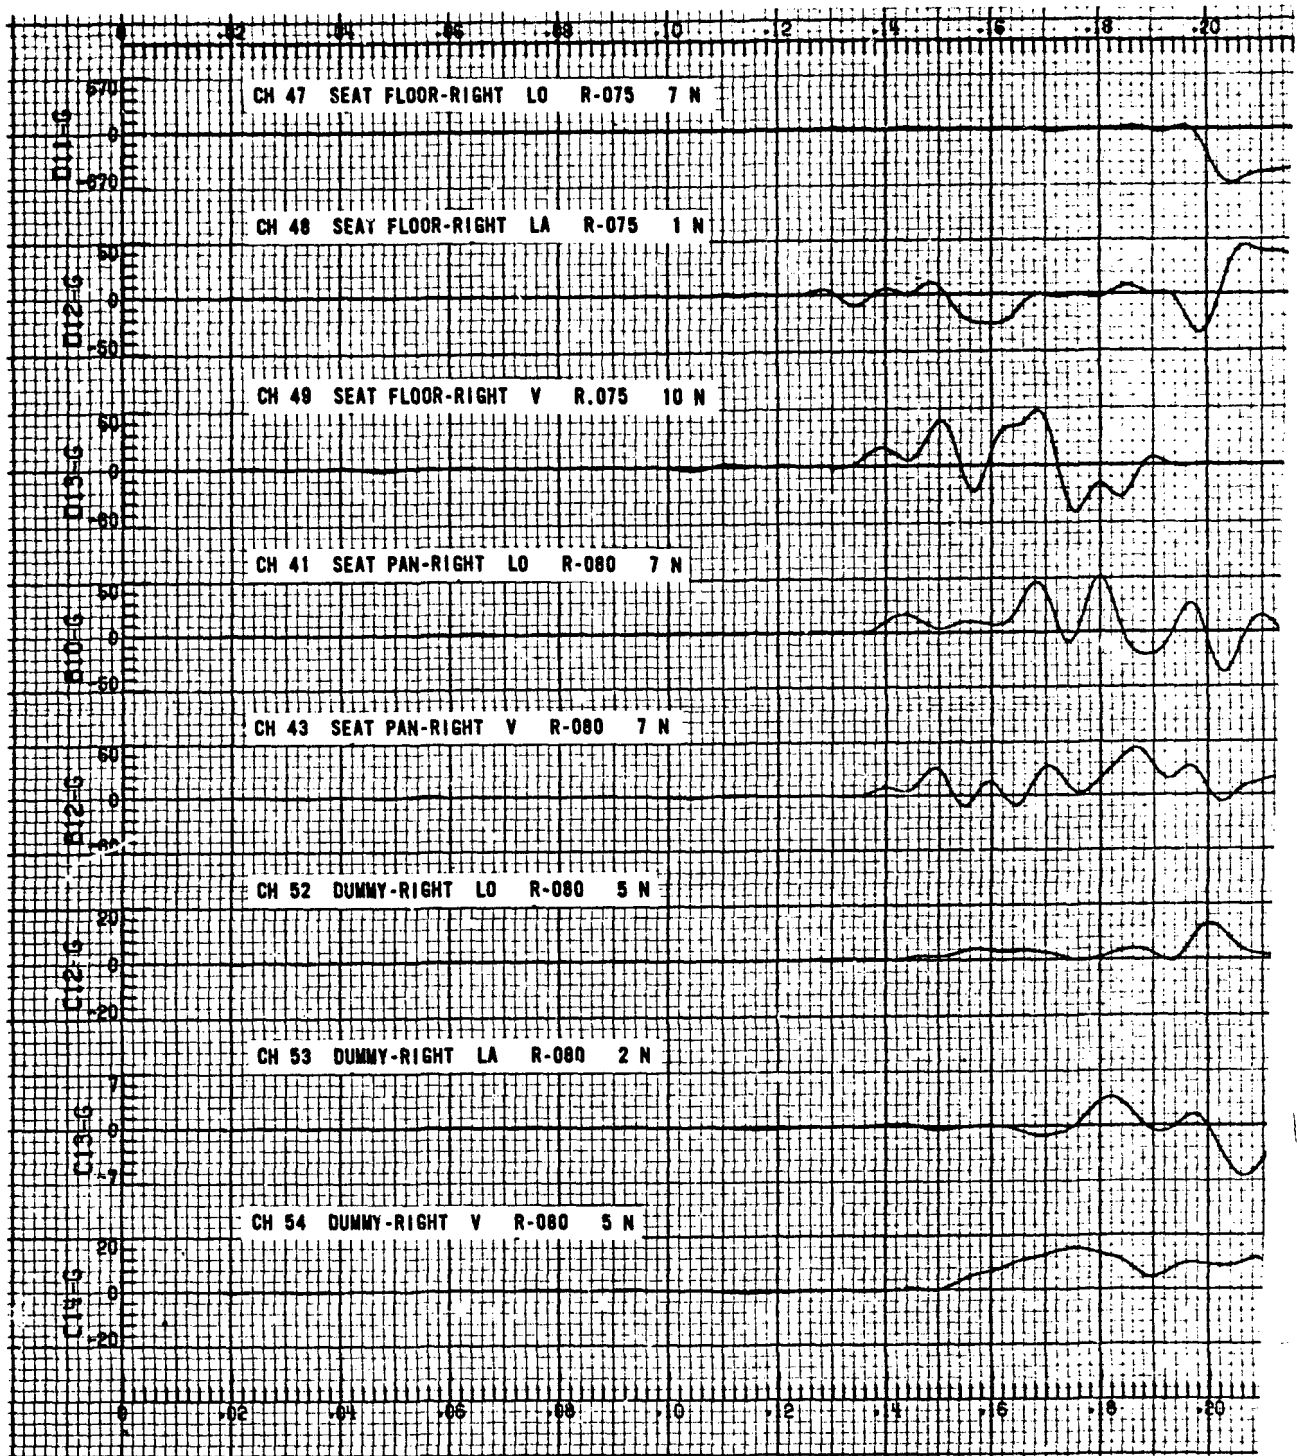
Crash force attenuation from cockpit floor to seat to occupant is shown in Figures 27 and 28 for the pilot and copilot stations respectively.

Figure 27. Pilot station decelerations.

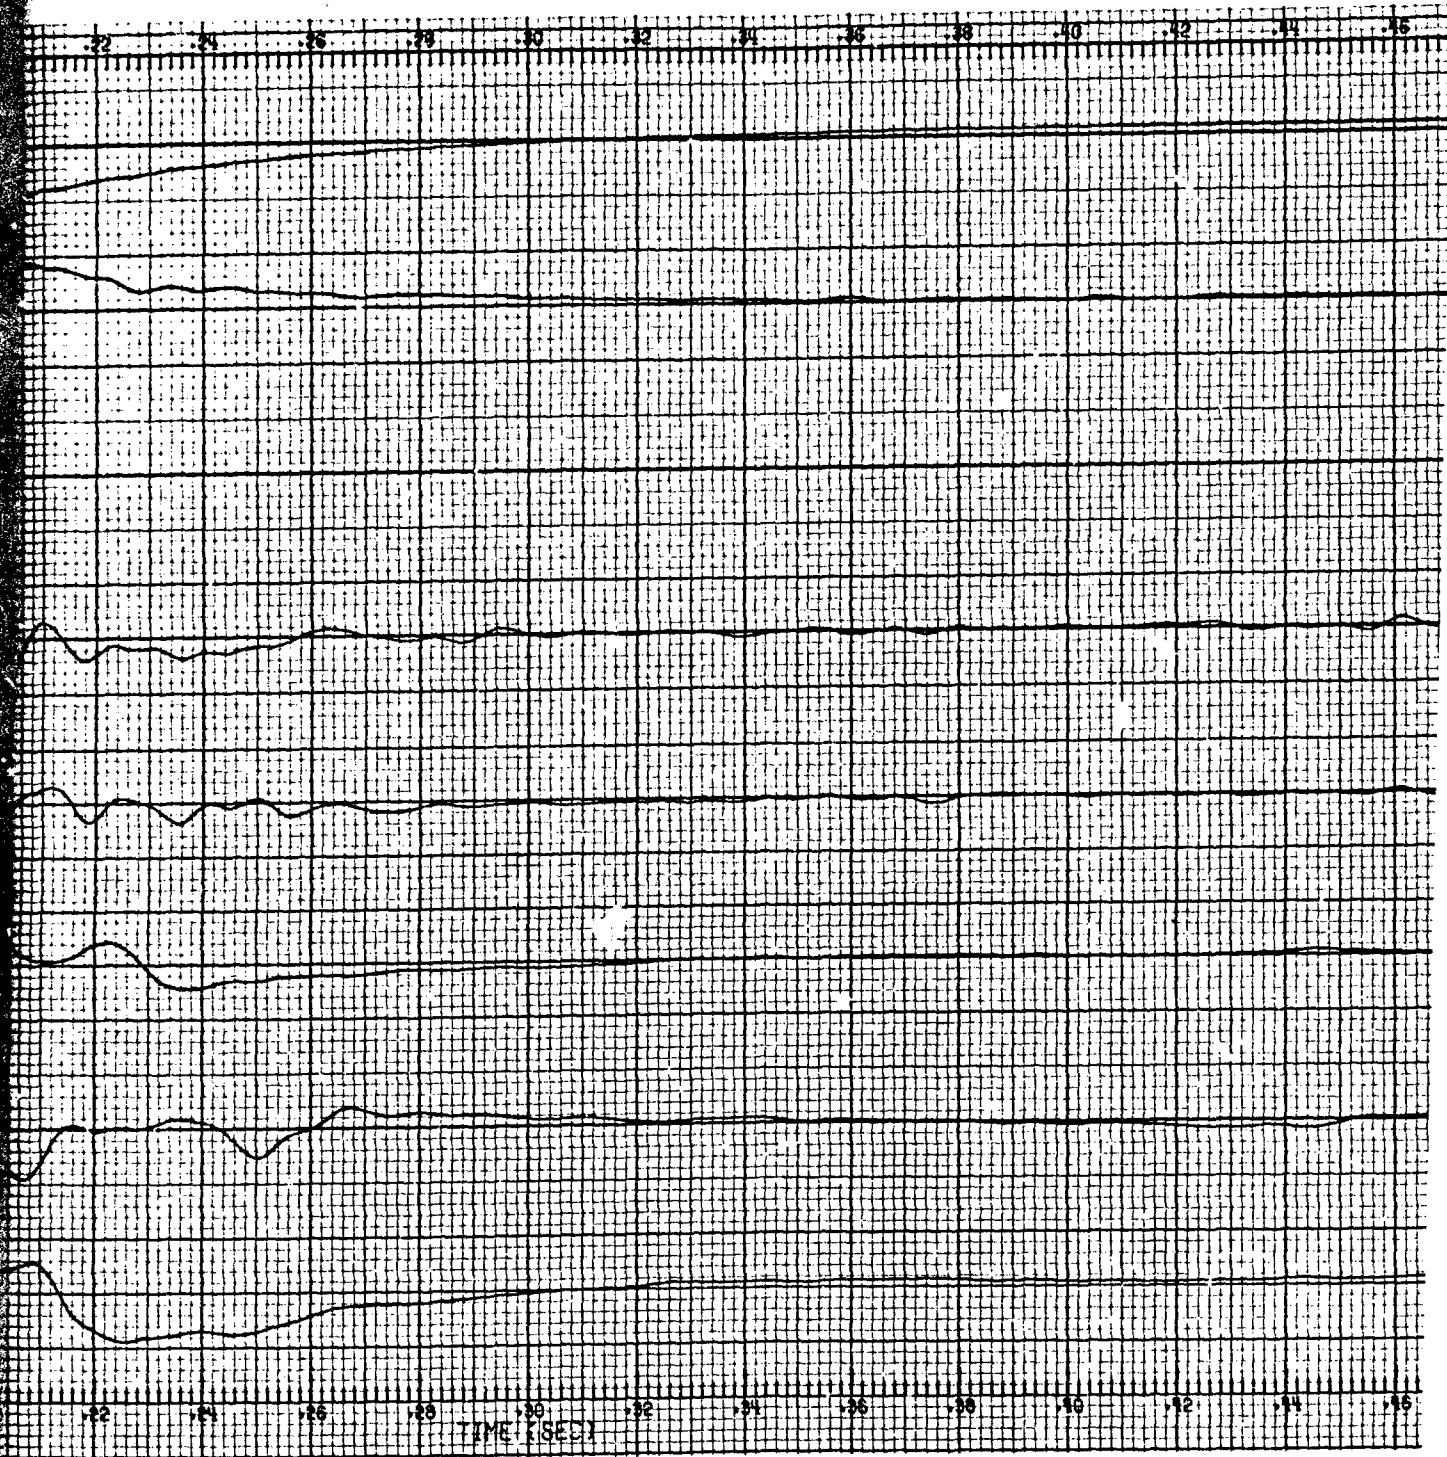
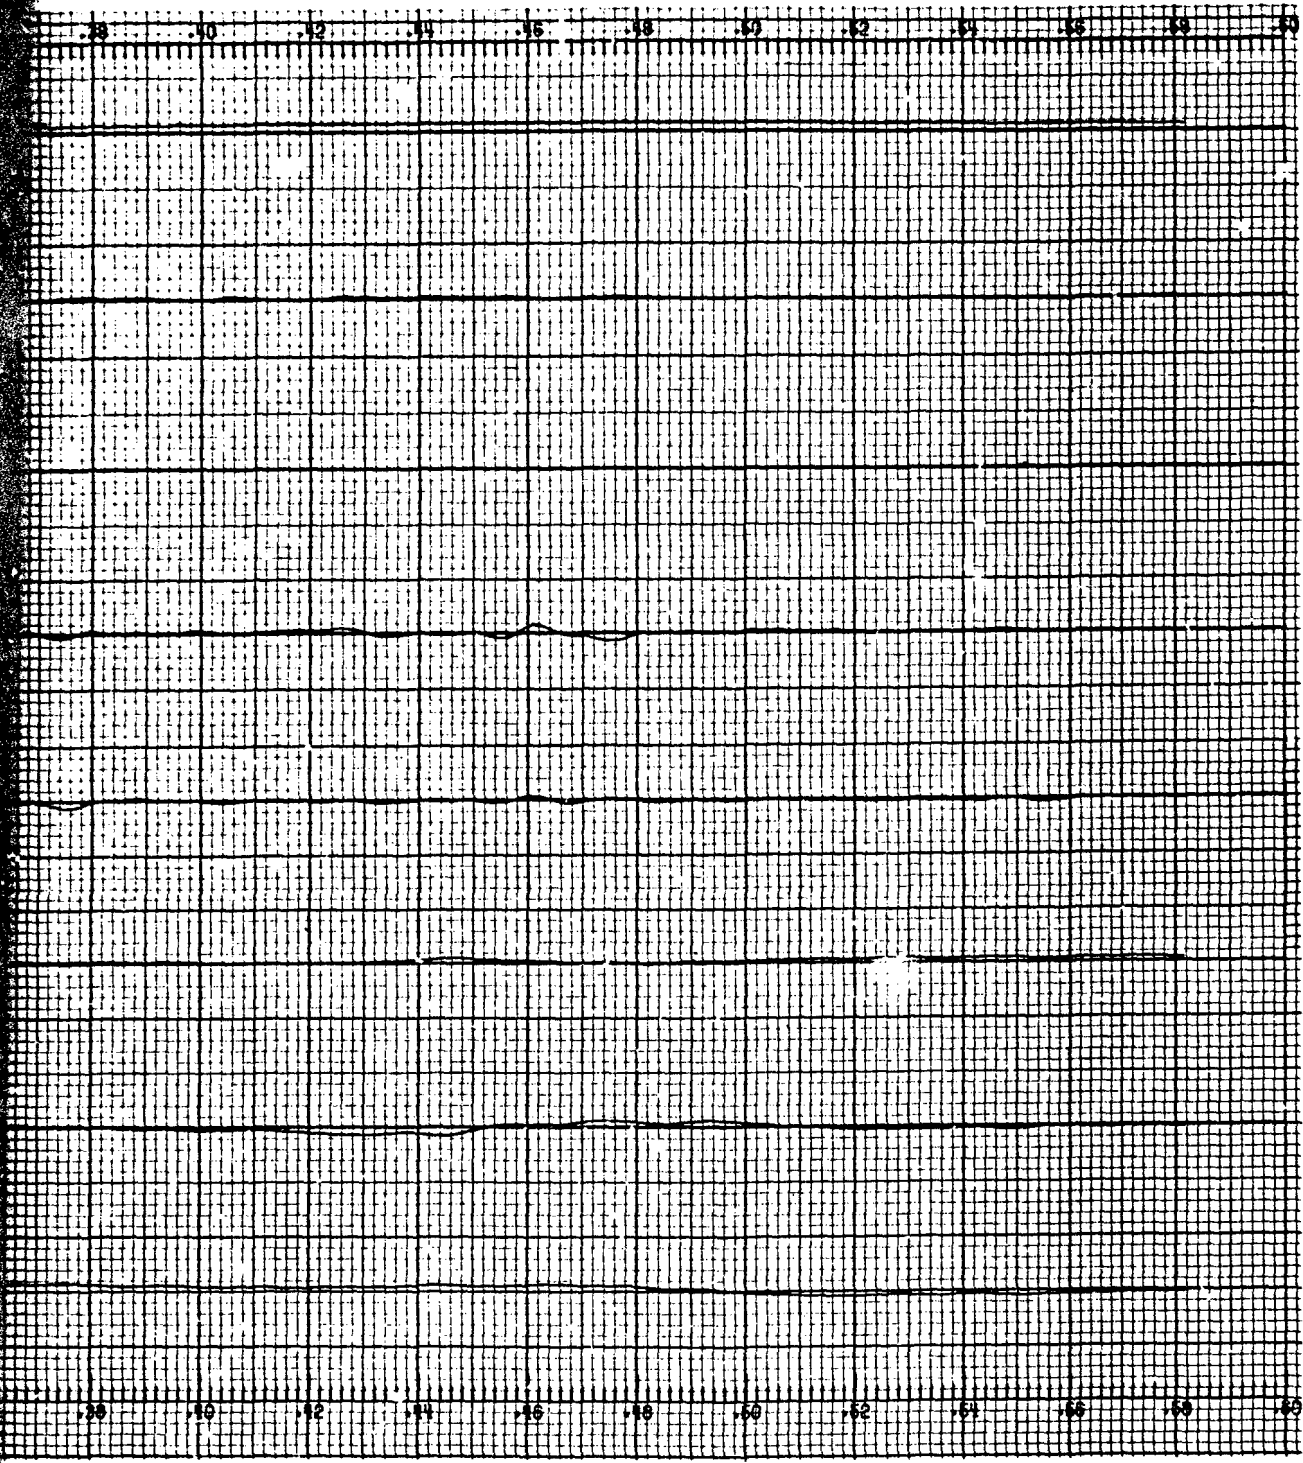
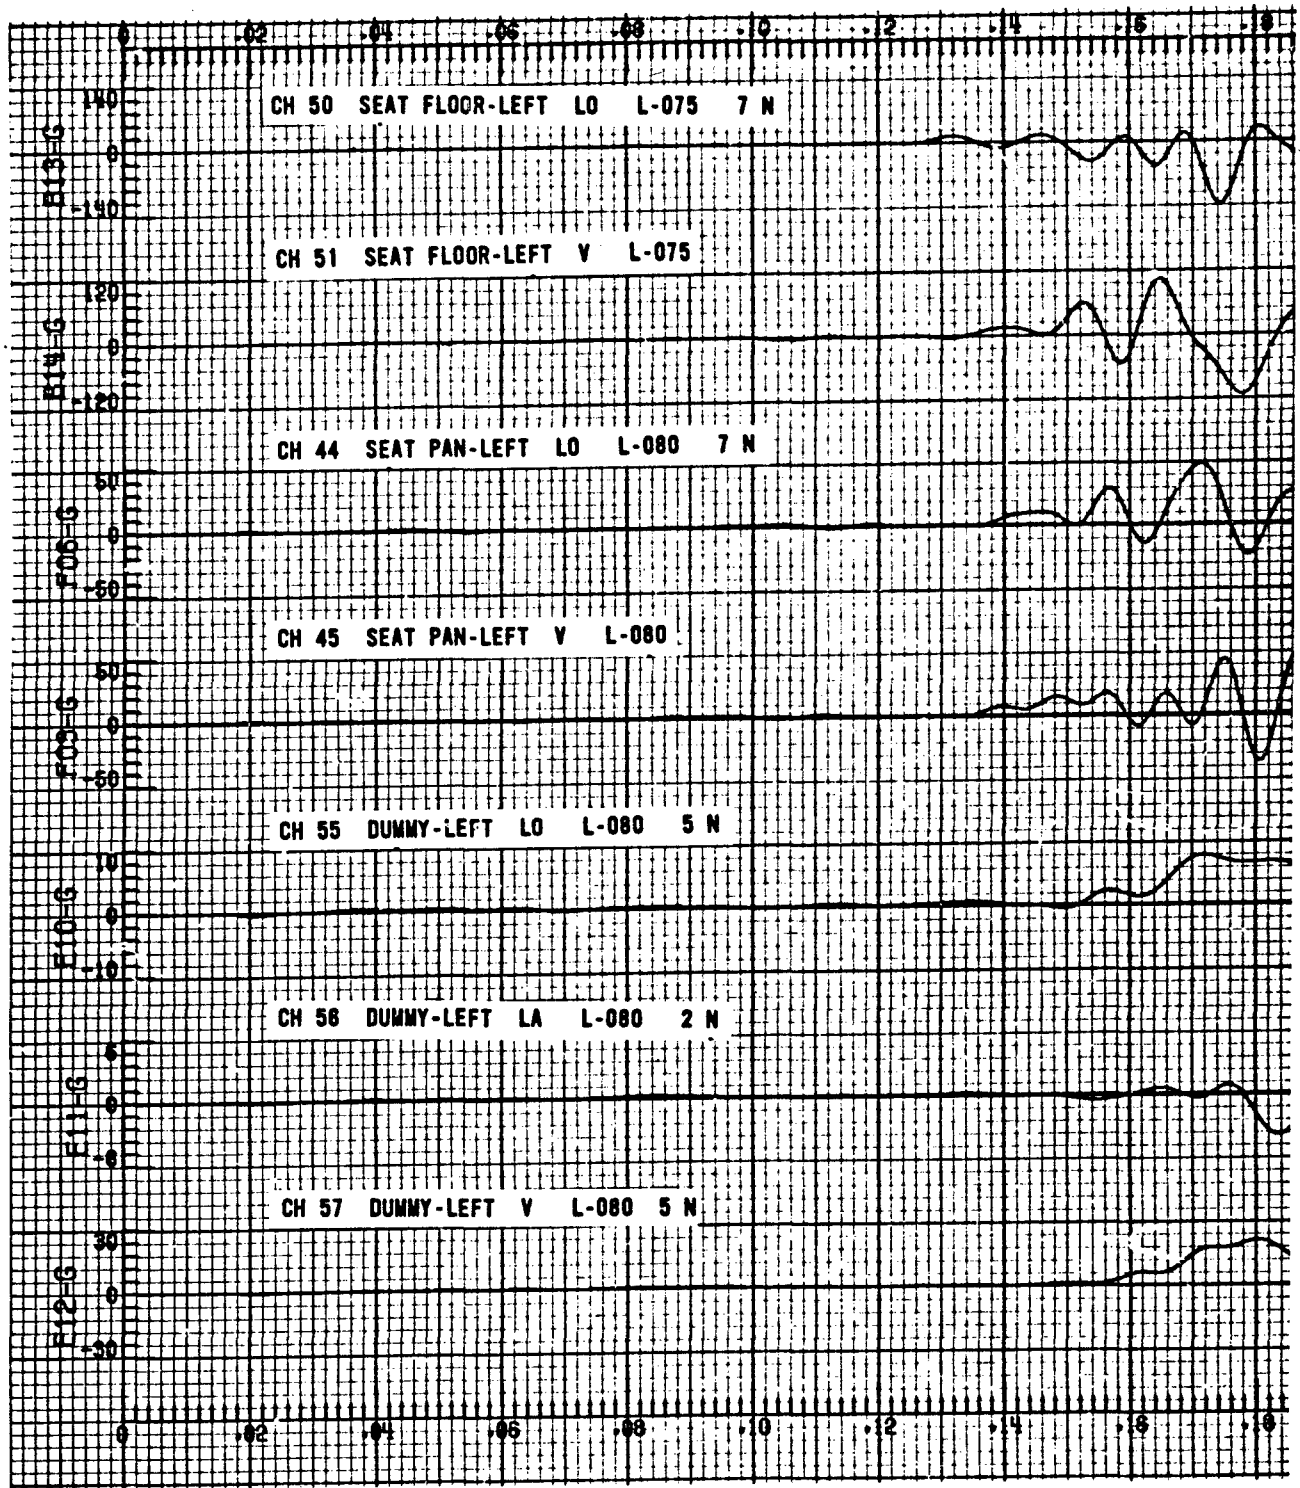
Figure 28. Copilot station decelerations.

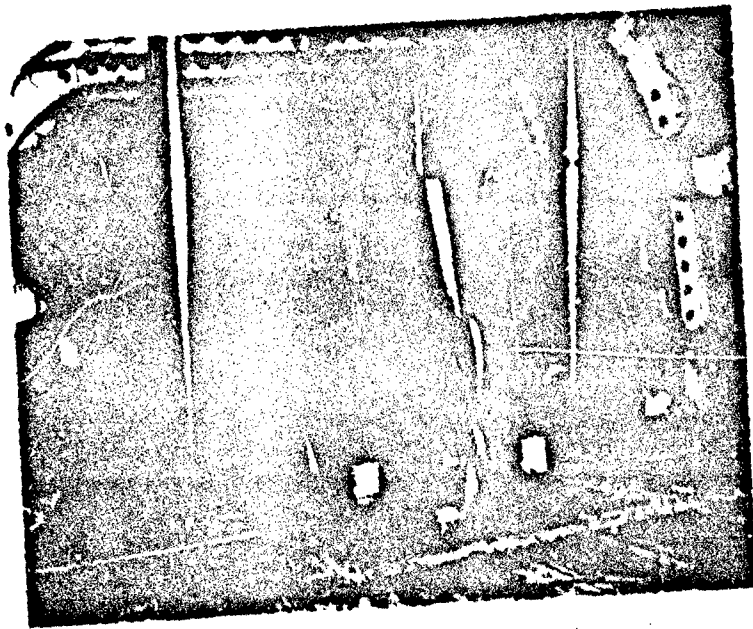
In the forward section of the cargo compartment, one trailer was restrained in the conventional manner with six MB-1, 10,000-pound-capacity chain restraint devices, and one pallet load was restrained with four CGU 5,000-pound-capacity nylon strap devices. The remaining trailer and pallet loads were restrained in a similar manner in the aft section of the cargo compartment with the load attenuators connected in series with the normal restraints (Figure 29).

Figure 29. Rear pallet load looking forward, after impact.

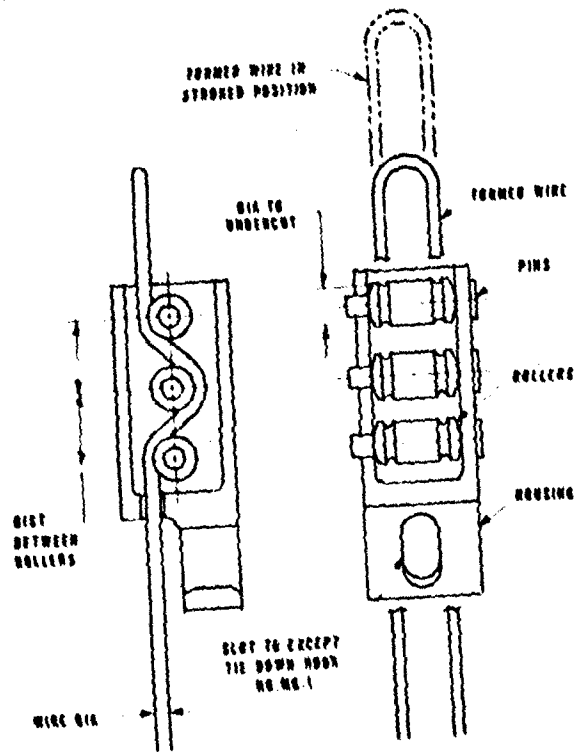
The load attenuators used in this test were the wire bending/extrusion type (Figure 30), whose dynamic characteristics can be controlled during the manufacturing process by varying the diameter and metallurgical properties of the wire and the distance between the extrusion rollers. The energy-absorbing devices that were used in series with the cargo restraints were designed with an initial extension force (breakout force) of 4,940 pounds, which is just under the maximum strength of the aircraft floor fittings.

Figure 30. Cargo load attenuator.

Noting the two failed floor fittings (ST-340), the results of this test suggest that the designed attenuator breakout force should be substantially lower to allow more energy dissipation and earlier stroking to avoid any chance of excessive peak load buildup. The load attenuators used in this test were designed with a breakout force of 4,940 pounds, which now appears to be too high for maximum system energy dissipation in this case, and perhaps too close to the ultimate strength of the floor fittings in the CH-47 helicopter.

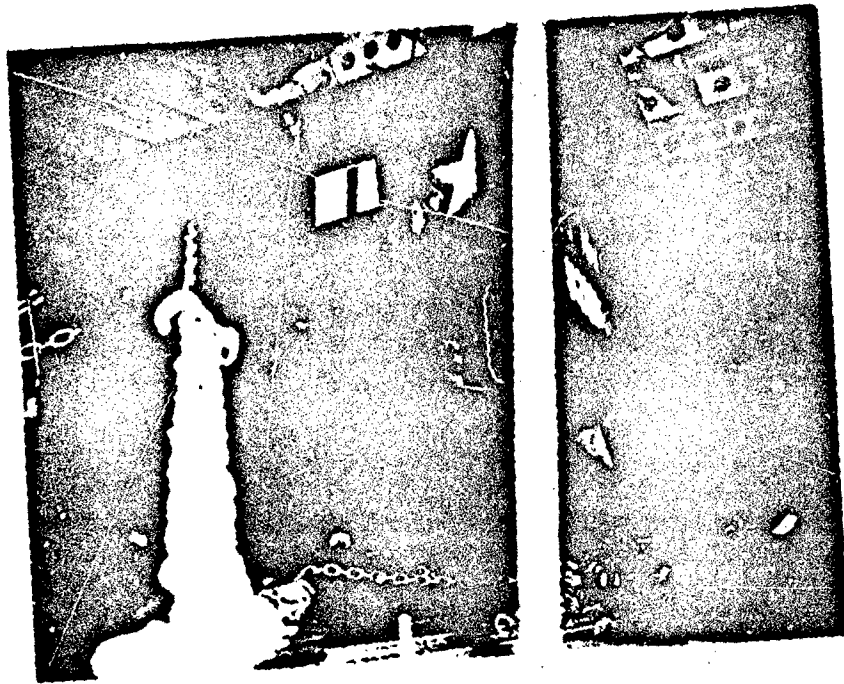
Of the four items of cargo in the helicopter, the aft trailer equipped with load attenuators in series witn the restraints was the only item to sustain major damage.

The aft trailer experienced high vertical G loads as evidenced by the 130 G peak measured on the floor beneath the trailer. These high vertical forces compressed the trailer springs, causing the shackles to penetrate the floor and to severely distort the axle, the wheel rims, and the chassis (Figures 31 and 32). The trailer rebounded from this position and induced loads of sufficient magnitude simultaneously in all restraints to stroke the attenuators on both the forward and lateral restraints and to fail the two aft restraint floor fittings. The reason that the attenuators in series with the aft restraints did not stroke and prevent failure of the floor fittings is not clearly understood. The nonstandard attachment of the starboard floor fitting to the base of the crash data package may have contributed to its failure.

Figure 31. Rear trailer looking forward from starboard side, after impact.

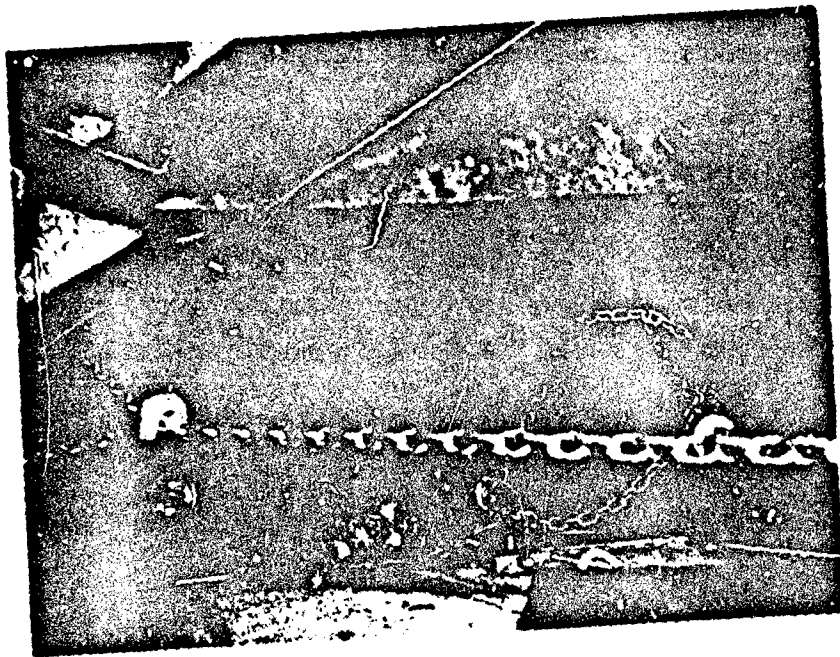
Figure 32. Rear trailer looking forward, after impact.

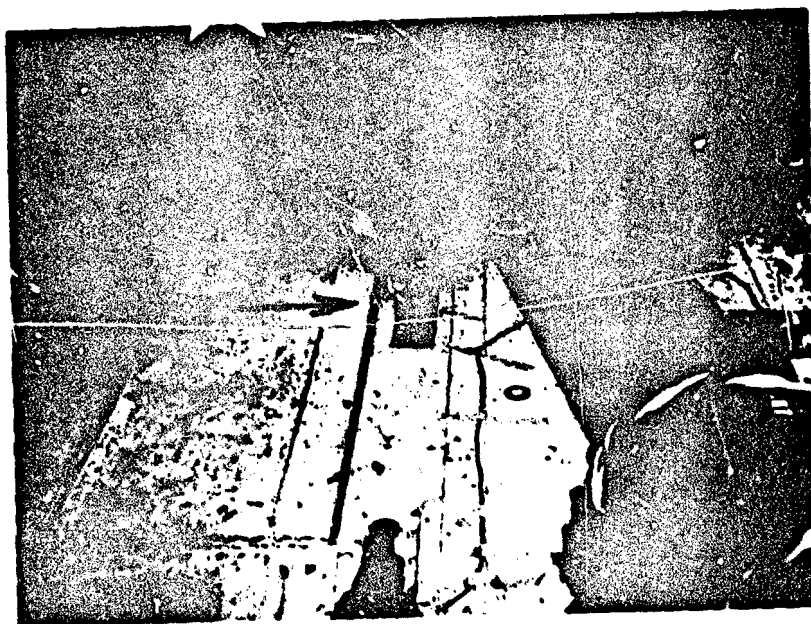
The port floor fitting (ST-340) was subjected to tensile loads severe enough to cause its mounting bolts to tear aftward through the floor for a distance of 7/8 inch without stroking the load attenuator (Figures 33 and 34). In this case the integrity of the load attenuator was questioned. Unfortunately, load cells were not available for direct load monitoring of the aft restraints. The forward trailer also experienced a bent axle from vertical G loads of 80 G peak measured on the floor beneath the trailer, although it was still serviceable after impact, as was most of the cargo. However, the crushed and distorted fuselage of the helicopter prevented the immediate removal of the cargo without special equipment.

Figure 34. Rear trailer, aft restraints, after impact (station 340).

A laboratory test was conducted at ATL in an attempt to learn why the floor fittings at ST-340 failed without extension of the load attenuators. The objective of the laboratory test was to determine the exact load at which the two unextended attenuators, which were attached to the floor fittings at ST-340, would break out and begin to stroke. With this information, it could be assumed that the tie-down fittings were subjected to loads just short of this amount. A third unused load attenuator was stroked completely in 141 milliseconds to simulate a crash pulse.

The results of these tests suggest that both floor fittings at ST-340 could have been subjected to loads up to approximately 4,600 pounds, since some indication of attenuator platten wire deformation would have been evident at loads above this level. CH-47 helicopter floor fittings have failed under static test loads of 5,050 to 5,150 pounds in the past; however, the age, corrosion, and general deterioration of this particular CH-47 fuselage probably contributed to early failure of these fittings.
