USARTL-TR-78-22

# CH-47 CRASH TEST (T-40) STRUCTURAL, CARGO RESTRAINT, AND AIRCREW INFLATABLE RESTRAINT EXPERIMENTS

L. Burrows, R. Lane, J. McElhenney

April 1978

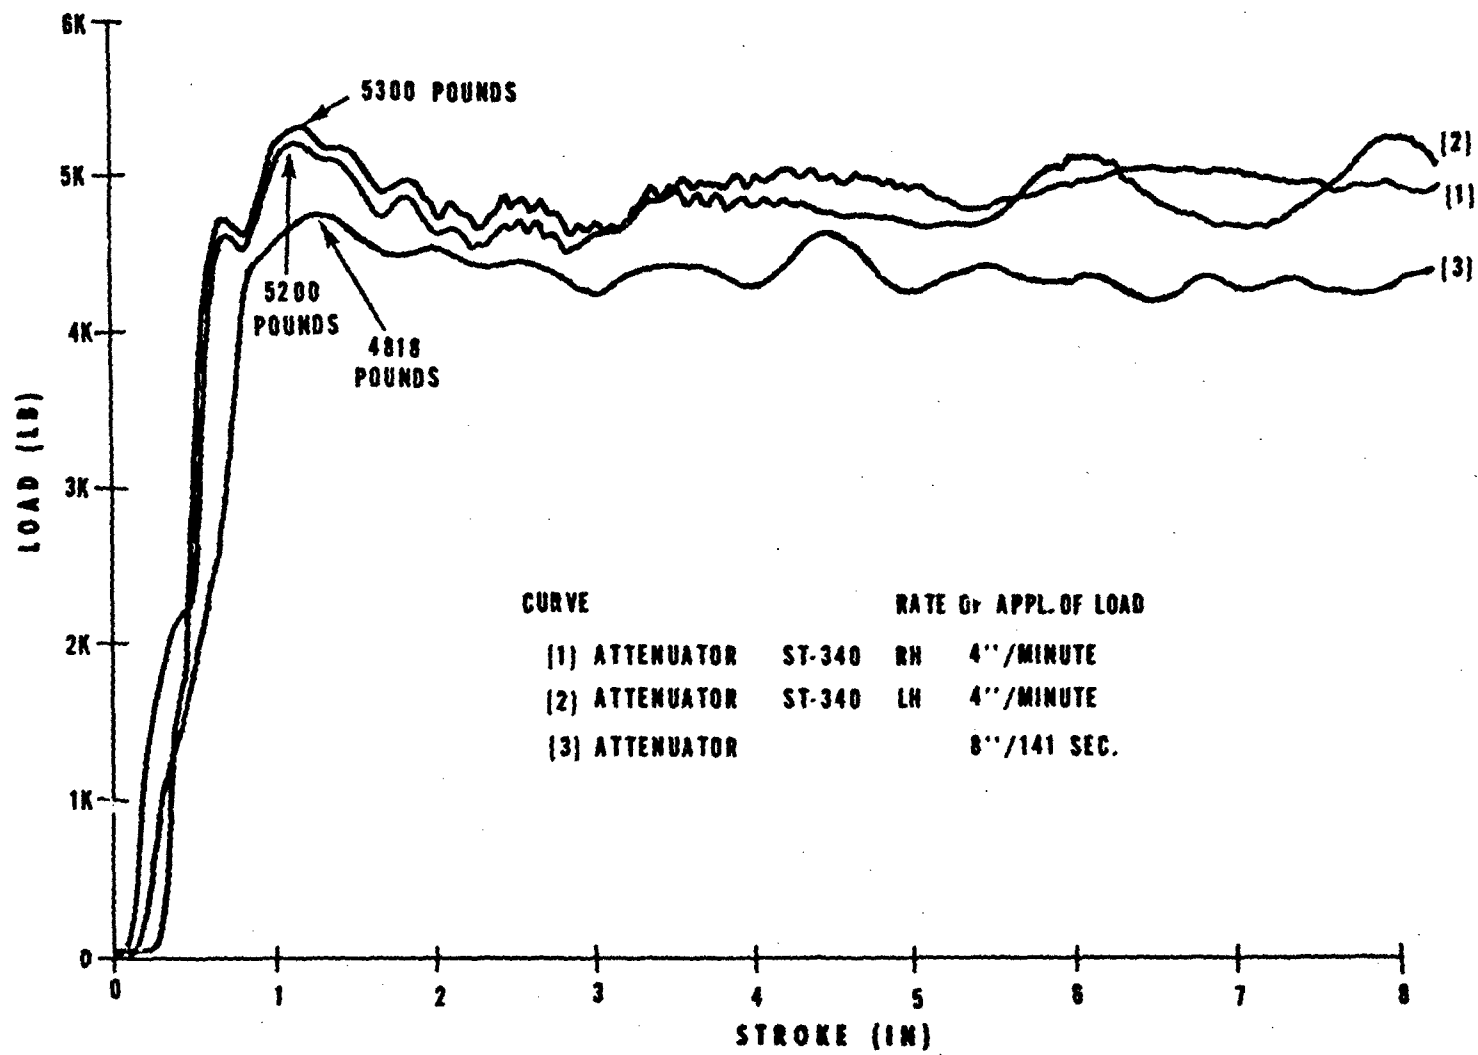
Under test conditions, both attenuators achieved peak loads of 5,200 and 5,300 pounds (breakout force) and stroked at level loads of 4,800 and 5,000 pounds, which was above their design performance of 4,940 pounds peak load and 4,600 pounds stroking load (Figure 37).

The results of these tests suggest that both floor fittings at ST-340 could have been subjected to loads up to approximately 4,600 pounds, since some indication of attenuator platten wire deformation would have been evident at loads above this level. CH-47 helicopter floor fittings have failed under static test loads of 5,050 to 5,150 pounds in the past; however, the age, corrosion, and general deterioration of this particular CH-47 fuselage probably contributed to early failure of these fittings.

Figure 37. Post-crash load attenuator laboratory tests.

Noting the two failed floor fittings (ST-340), the results of this test suggest that the designed attenuator breakout force should be substantially lower to allow more energy dissipation and earlier stroking to avoid any chance of excessive peak load buildup. The load attenuators used in this test were designed with a breakout force of 4,940 pounds, which now appears to be too high for maximum system energy dissipation in this case, and perhaps too close to the ultimate strength of the floor fittings in the CH-47 helicopter.

In selecting attenuators for cargo restraint, a much greater margin should be allowed between the ultimate strength of critical components and the limit load value than was allowed in this cargo restraint experiment.

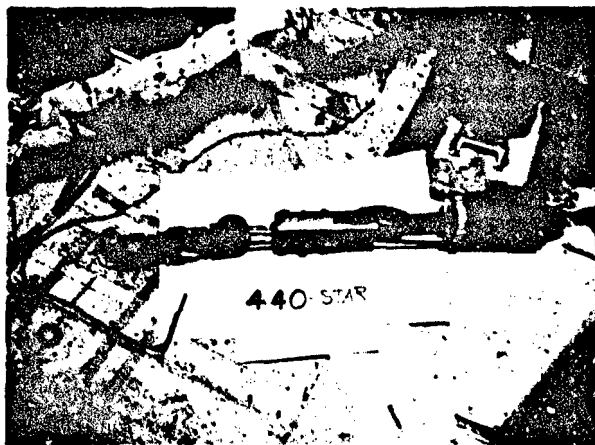
The load attenuators used in this experiment were designed to fit in series with the MB-1 chain, or the CGU strap restraint devices; however, several operational problems were experienced that will require future hardware modifications. One of the hooks on the CGU strap restraints did not fit the attenuator body and a shackle was required. The long sections of wire extending out from the attenuator body interfered with operation of the MB-1 latch and the tensioning device and should be repositioned in the final operational hardware (Figure 38).

Figure 38. Partially extended energy attenuator showing interference of platten wire with tension adjustment wheel on MB-1 chain restraint.
